# Stripping Phenomenon in Thick Pavement Top Layers

**ABSTRACT:** Most of the heavily trafficked French roads, like thick pavement structures, are now thirty or forty years old. Since construction, top layers only, have undergone one or more repair operations. Traditional rehabilitation works consist in overlaying the old wearing course or in milling it before covering it with a new overlay. For a few years, unusual deteriorations in highway structures, like pothole series or top layer delamination, have appeared. These phenomena generally occur after winter and more precisely during rainy events. The purpose of this paper is to investigate three cases of degradations observed for both rehabilitation types. The mechanics of the action causing upper layer deteriorations has to do with freeze-thaw processes combined with humidity and traffic. Nevertheless, other causes can add further to pavement degradation long before any surface deteriorations appear. The presence of water near the surface, for instance, can explain some of the damages observed. The fatigue of the layers during hot weather periods can also be at the origin of damages, even though rutting is more traditionally exp

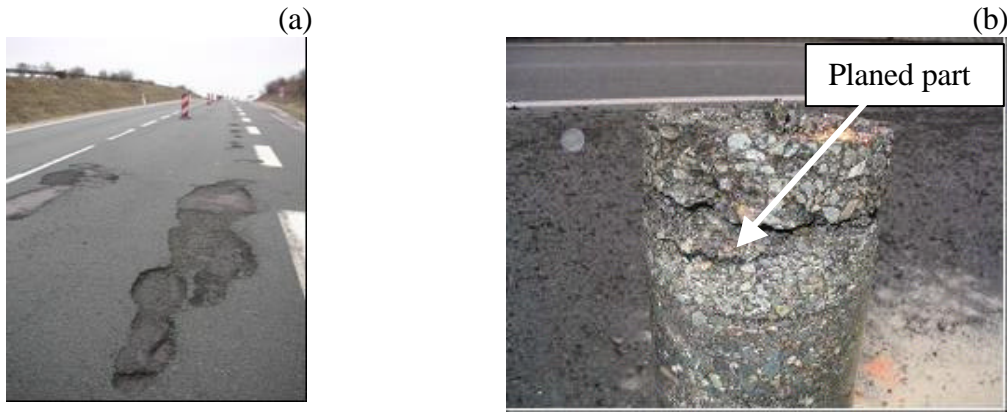
The degradation survey carried out in 2005 reveals clean transverse and longitudinal cracks at wheel track level on the traffic lanes throughout the 2.5 km of the section considered. The first 500 meters of the section also present extensive repair works and significant branched longitudinal cracking. Previous deflection measurements, however, had not shown any particularly structural failure sign. During winter 2005/2006, many potholes, which made emergency repair sometimes several times a day necessary, appeared in a few days (Figure 1). These 5 to 12 cm deep and several square decimetre large potholes were numerous, close to each other and located on the climbing lane, preferentially on the lane wheel tracks.

The samples extracted from the pavement after degradations had appeared show that the hydraulic bound base course is in very good condition whereas the cracked and crazed wearing course rests on two degraded layers.

Figure 1: Pavement whose wearing course is laid on a planed surface.  
 (a) Potholes in chains (b) Damaged binder course under the wearing course.

The first case demonstrates that, in certain conditions, milling the upper part of the pavement before laying a new wearing course can weaken the first interface. The mechanical action of the planer, whose speed is sometimes too high, can be the cause of microcrack formation within the remaining underlying layer evolving under the action of traffic (Figure 1b). Planing also implies that the lowest part of the former wearing course can sometimes remain on the pavement when milling depth is not deep enough. This remaining 1 or 2 cm thick layer certainly constitutes a weak point for the structure. It can, indeed, suffer from a deficiency in compaction. Moreover, at the bottom of the new course, there are not one but two interfaces, between which a thin, bitumen layer where infiltration water can accumulate, is found. In rainy, wintry conditions, this zone close to the pavement surface is *a priori* particularly sensitive to freeze-thaw cycles.

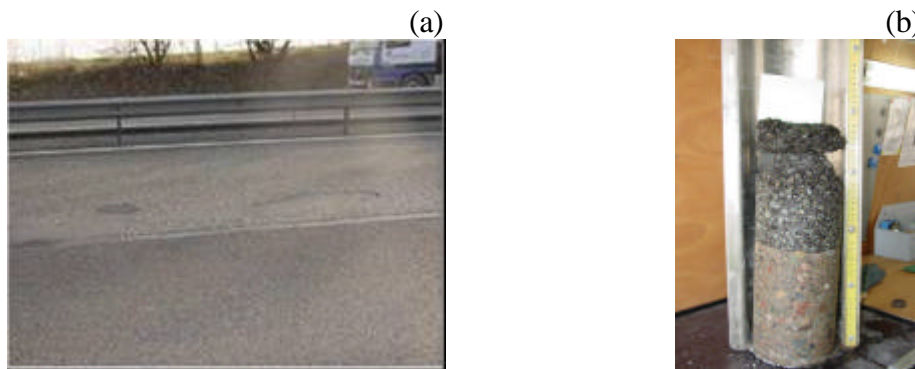
During winter 2007/2008, potholes developed within a very short lapse of time requiring frequent and urgent repairs (Figure 2).

Figure 2: Pavement whose the drainage system is unsatisfactory.  
 (a) Pothole repair (b) Core sample showing base and sub-base in good condition.

Pothole dimensions could exceed one square decimetre, be 6 to 8 cm deep and were found on both the slow and the fast lanes over a linear section of nearly 3 km. They were principally located at the lowest point of the longitudinal section where there is no water outlet.

The problems observed in the second case are obviously arising from the absence of a satisfactory pavement drainage system, for which long-term adverse effects are well known (Apul et al. 2002). A poor or non-existent drainage system, not carefully designed geometry, a locally unfavourable road configuration (low points, superelevation transition zone, for instance) are as many parameters connected to pavement construction or operating, which can cause the stagnation of runoff water within the pavements. Whole portions of road are then exposed to stripping and its ensuing damages: segregation of the binder/aggregate pair, delamination, spontaneous water-in-bitumen emulsion phenomenon, etc. (Kiggundu et al. 1988, Hicks, 1991, Castenada et al., 2004a 2004b). Material coming off can increase under the action of traffic.

- pavement condition survey to detect saturated zones within foundations (visual survey after rain events, use of radar, etc.),
- treatment of the spotted zones with suiting materials and measures,
- improvement of already available laboratory tests in order to ameliorate the water resistance qualification of pavement materials and interfaces.

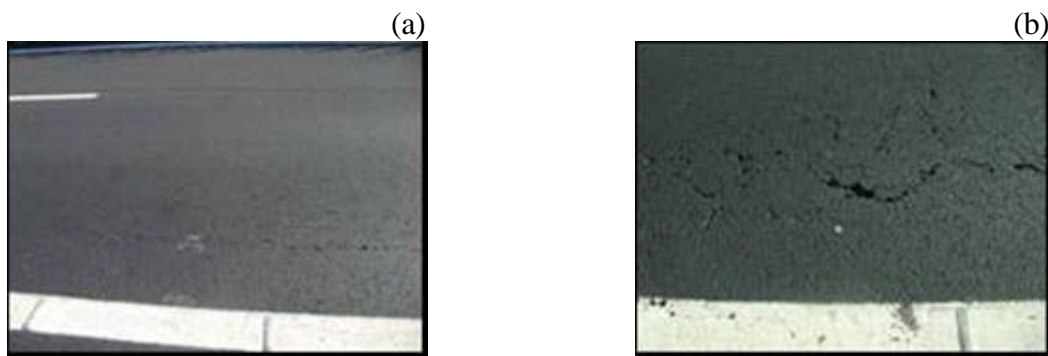
Figure 3: Longitudinal crack at wheel track level on the slow lane.  
(a) Initial crack (b) Crazing evolution.

Crazed zones evolve into a surfacing consisting of small separate blocks, which, in rainy wintry conditions combined with heavy traffic, can come off the road and require many selective repairs.

In the third case, the new wearing course, implemented by resurfacing, presents, ten years later, some longitudinal cracks mainly located on the wheel tracks. Cracking quickly develops into crazing while some pieces of surface material come off in rainy and wintry conditions. According to the cores taken on the first longitudinal crack, that crack is only on the height of the upper layer. As described in section 4, shear fatigue effects on the upper part of heavily-trafficked pavements (bottom of the wearing course/tack coat/top of the binder course), especially during hot periods, could be the long-term cause of the longitudinal cracking observed. The phenomenon occurs although the tack coat is good as shown by the core samples of case n° 3 taken on and off of the wheel tracks. The crack probably starts at the bottom of the wearing course and go up to the top, then water can go down in the interface. The traffic has a knead action on tack coat with water which set out in emulsion. So the

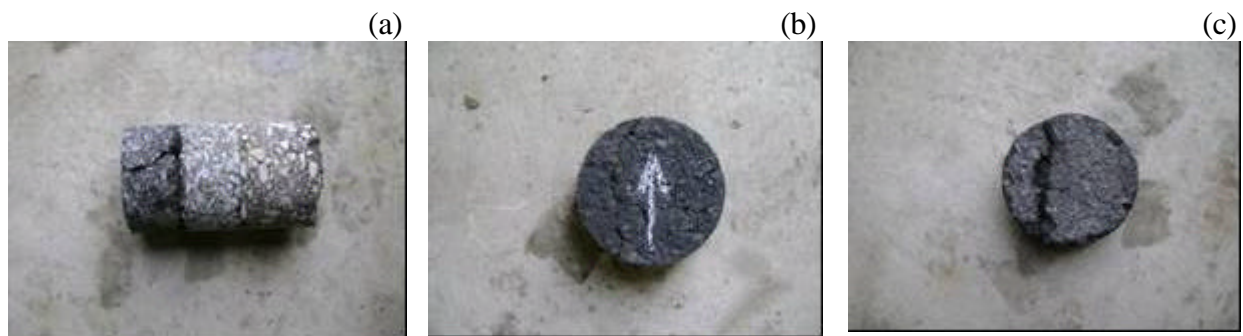
Figure 4: Core sample taken at longitudinal crack level.  
(a) The first interface is detached whereas the first layer is cracked straight down.  
(b) View from above the wearing course. (c) View from below the wearing course.

The core samples taken on the newly formed longitudinal cracks show that cracks do not go deeper than the first interface (Figure 4a). The photographic view of the wearing course from above shows an open crack with a few spalls (Figure 4b). The view from below the course, on the other hand, reveals that the crack is wider opened than at the surface (Figure 4c). Cracking probably started from the bottom of the wearing course long before appearing at the surface and then spread upward across the whole thickness of the layer.
