A Porous Surface Mastic Asphalt Course on the Honshu-Shikoku Bridge Expressway

This report presents the results of the preliminary survey and the surveys conducted in the test zone just after and two years after installation to examine the pavement condition and performance in terms of drainage. The data provided by these surveys are short-term, but were used to assess the applicability of this pavement construction method and are therefore reported together in this paper.

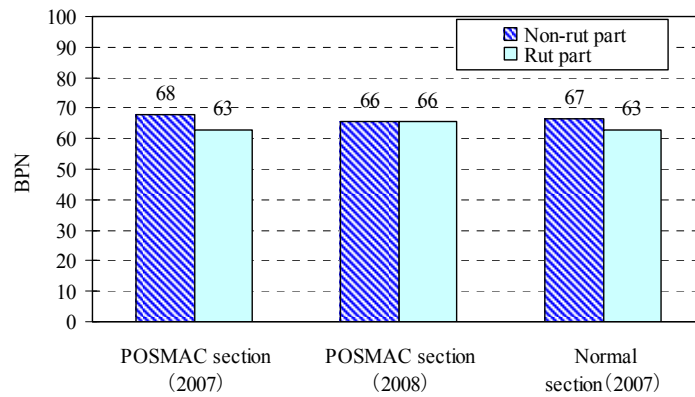
Figure 4: Skid resistance

The results of measurements of the skid resistance (BPN) of the road surface taken with a pendulum skid resistance tester are shown in Figure 4. Results indicate that the non-rutted portions have a higher skid resistance, which is the typical finding.

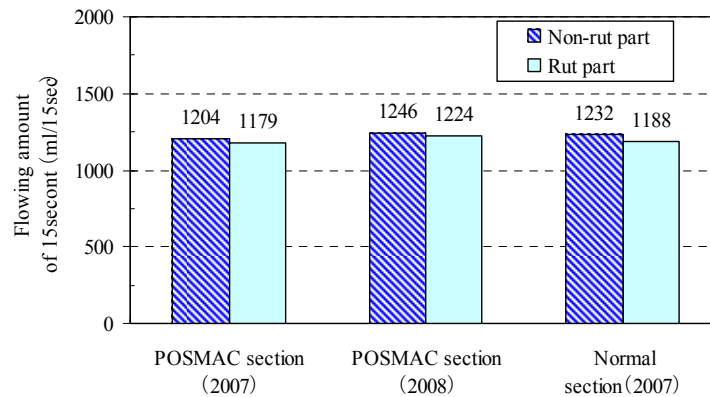
Figure 5: Water seepage volume

The results of measurements of the water seepage volume taken with an *in situ* permeability tester are shown in Figure 5. This was slightly higher in the non-rutted portions than in the rutted portions of all of the sections, but there were no large differences. All of the test locations were found to be in good condition after at least a year following installation,

achieving rates of at least 1000 (ml/15 s).

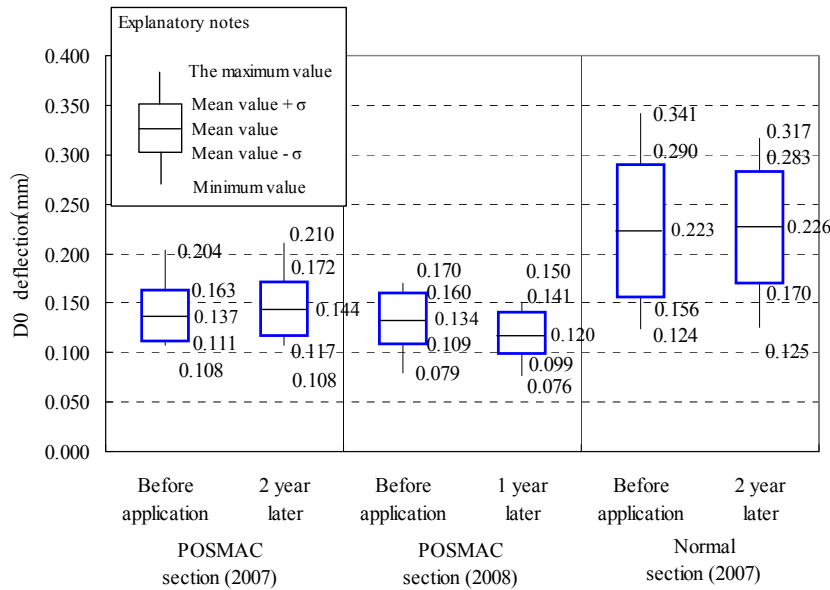
Figure 6: Pavement surface deflection (D0) found by FWD (maximum, minimum, mean, mean±standard deviation)

The maximum, minimum and mean±standard deviation of the pavement surface deflection (D0) before and after installation, obtained by Falling Weight Deflectometer (FWD), are shown in Figure 6. Large fluctuations in deflection were not seen following installation, and the surfaces were in good condition.

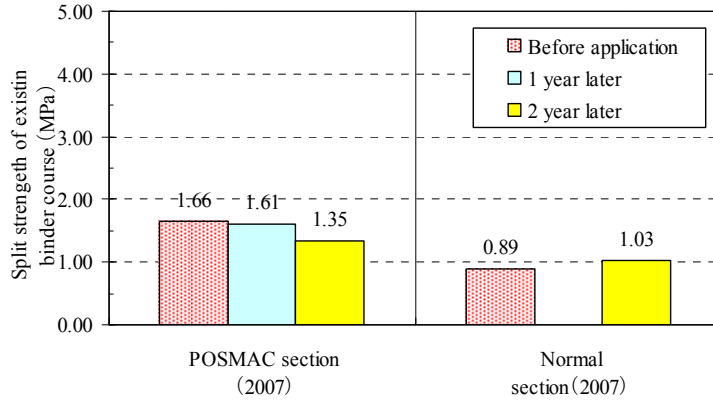
Figure 7: Split test

The results of the split strength tests are shown in Figure 7. Both the POSMAC section and the normal section tended to decline in split strength with the length of service, but both retained strengths above 1.0 (MPa), and were in generally good condition.

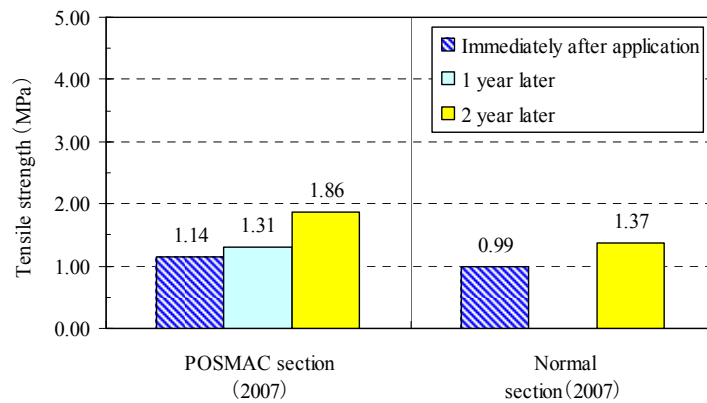
Figure 8: Tensile test

The results of laboratory tests of tensile strength are shown in Figure 8. The tensile strength tended to rise just after installation and the tensile strength of POSMAC remained above 1.0 (MPa) after two years of service. Both pavements remained in good condition.
