Emergency Repair of Runway after Cargo Plane Accident

ABSTRACT: It is always desirable for engineers to complete construction projects on schedule. However, emergency repairs after accidents at transportation facilities such as airports and highways have also played an important role since the accidents significantly affect users in several ways. This paper summarizes the emergency runway repair as a management system (i.e. operators, machines and materials) from the early establishment of a construction party to completion of repair, based on the case study of a cargo plane accident at Narita International Airport. Three factors influencing the repair were examined through the case study: area, decision for section and repair methods; the following conclusions were drawn in this study. In terms of the decision for the repair area, field results indicate that although softening of the asphalt surface resulted from the fuel leakage from the cargo plane on the runway, no significant breakages were confirmed on the surface. Therefore, it was concluded that the softening did not have any significant effect on service, as the grooving of the runway remained effective after the accident

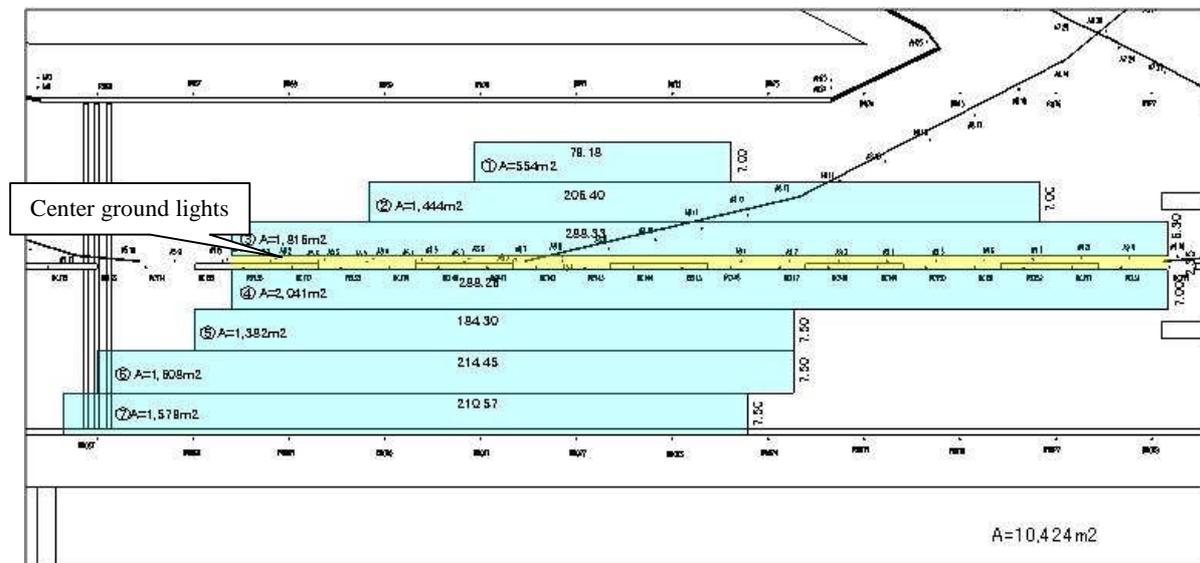
Figure 3: Plan of repair area

Figure 3 shows a plan of the repair area including the center ground lights. In the case of milling/overlay, normally, the removal and re-installation of the ground lights in the center of the runway is required before and after paving, respectively. However, since it was predicted that such repair work would take much time, priority was given to repairing the pavement; the re-installation of the lights would be considered after those repairs.

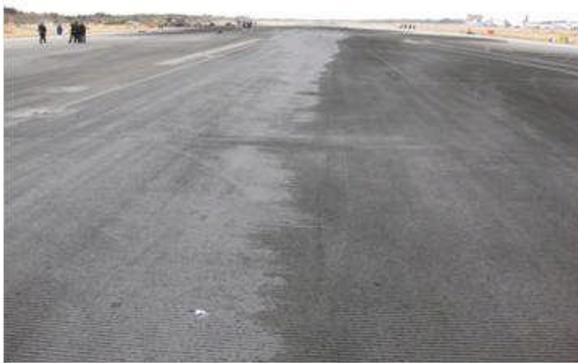
In terms of the depth of pavement damage, it was judged from on-site inspections that the depth of damage caused by the actual aircraft and the cutback of the asphalt surface by fuel leakage was minor and only affected the surface layer (see Figures 4 and 5). Thus, it was recognized that 5-cm milling/overlay would be enough to remove the damaged section because the softening was less than 5 mm deep.

Figure 4: Damaged runway surface

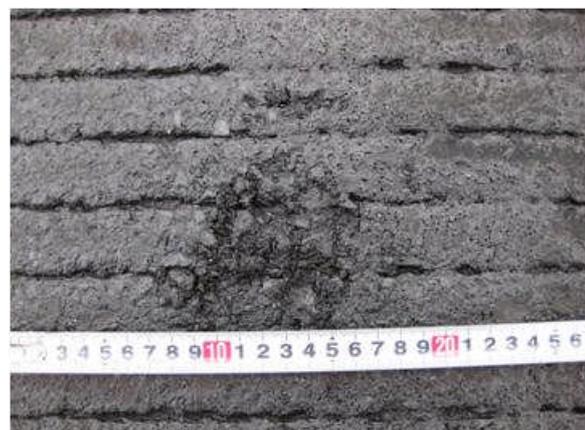
Figure 5: Cutback of the asphalt surface caused by fuel leakage
