Performance of Permeable Asphalt Pavements in Traffic Roads after Five years

T. Ayabe , K. Kubo

Public Works Research Institute, Tsukuba, Ibaraki, Japan

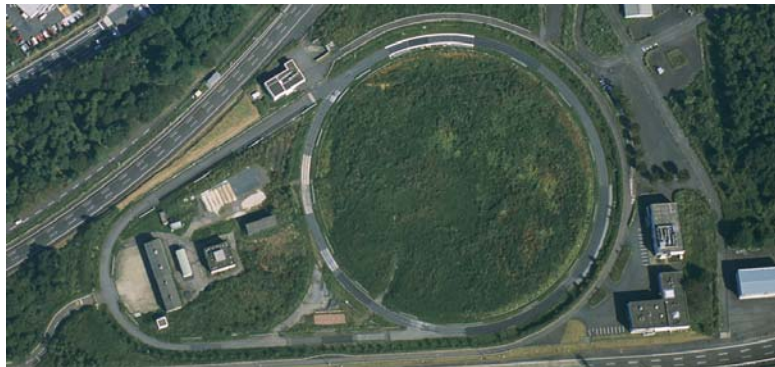
Photo 1 : Pavement Test Field

To identify how the difference in vertical pavement configuration and rainwater drainage mechanism affect pavement durability, an accelerated loading test was conducted using four full-size permeable pavement sections prepared at the Pavement Test Field at the Public Works Research Institute (PWRI). The Pavement Test Field is used for evaluating pavement durability by driving heavily loaded vehicles on full-scale pavement applied to a test track of 628 m in total length (Photo 1). Trucks of the most commonly used type in Japan were modified for use as heavily loaded vehicles to be driven by unmanned operation assisted by GPS (Photo 2). Four heavily loaded vehicles were operated simultaneously to drive at a speed of 40 km/h. The axle loads of each vehicle are set to 49kN (front axle) and 127kN (rear axle).

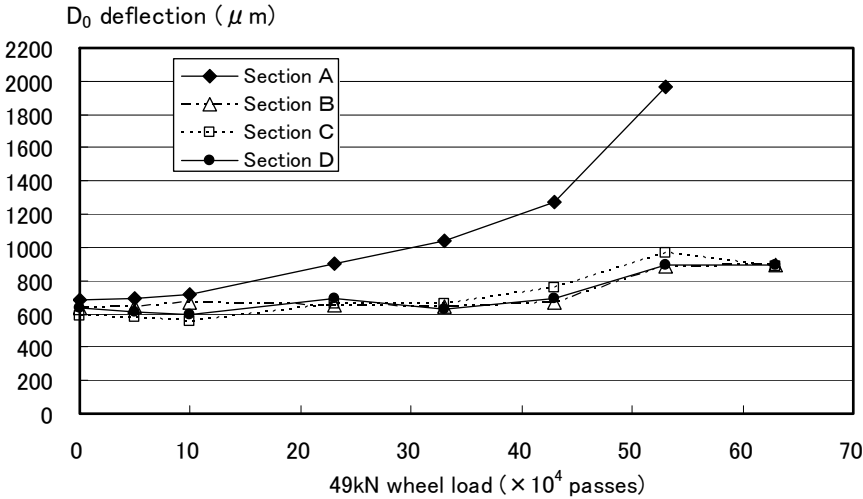
Figure 2 : Progress of D₀ deflection

Figure 2 shows the progress of deflection immediately underneath the loading plate measured using FWD (hereafter referred to as “D₀ deflection”). The increase of D₀ deflection was moderate in Sections B, C, and D, while that in Section A progressed greatly. Likewise, the rut depth progressed more greatly and the pavement distress occurred earlier in Section A compared with the other three sections, as shown in Figure 3.

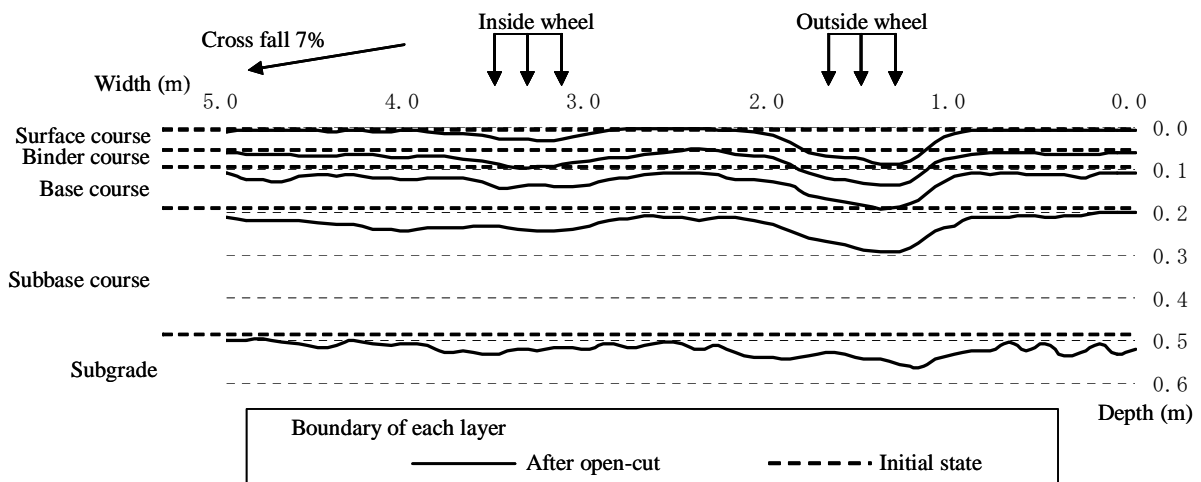
Figure 4 : Measurement results for open-cut cross section

The cause for the earlier distress in Section A was investigated by cutting open the pavement body. A view of the open-cut cross section is shown in Photo 3, and the results of measuring the respective pavement layers are shown in Figure 4. The asphalt mixture layers were found to have deformed downward along the pavement ruts. The deformation even reached the subgrade, pushing base course materials into the subgrade. These phenomena are considered to be due to reduced bearing capacity of the subgrade that was water-soaked for a long time.

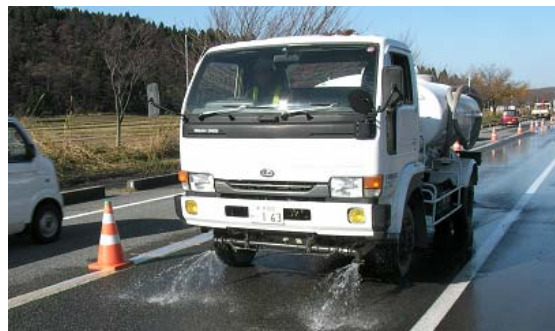
Photo 4 : Water sprinkler car

The follow-up observations were conducted once every year after the start of service. The rut depth and D_0 deflection were measured to inspect the pavement durability. Watering experiments were conducted to inspect the capability to control rainwater runoff. In the watering experiments, the water sprinkler car shown in Photo 4 was used to sprinkle water, and the amount of runoff from the drainage pipe which was set on the upper surface of the subgrade was measured. In addition, the natural rainfall was measured throughout the year to measure the amount of runoff from the drainage pipe on the upper surface of the subgrade like the watering experiments.

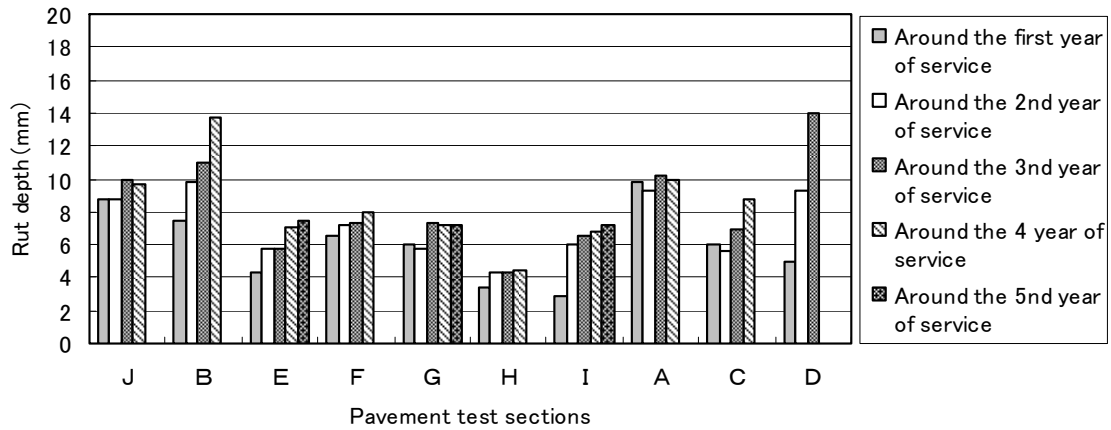
Figure 7 : Progress of rut depth

The progress of rut depth is shown in Figure 7. Rut depth is around 15 mm or shallower for all test pavement sections. No conspicuous progress in rut depth due to the start of service has been observed. With respect to other investigation as well, no conspicuous progress due to the start of service has been observed, nor have reduced subgrade bearing capacity or signs of cavity generation inside the pavement body been detected. Furthermore, no remarkable increase in D_0 deflection has been observed by the measurements using FWD conducted so far.

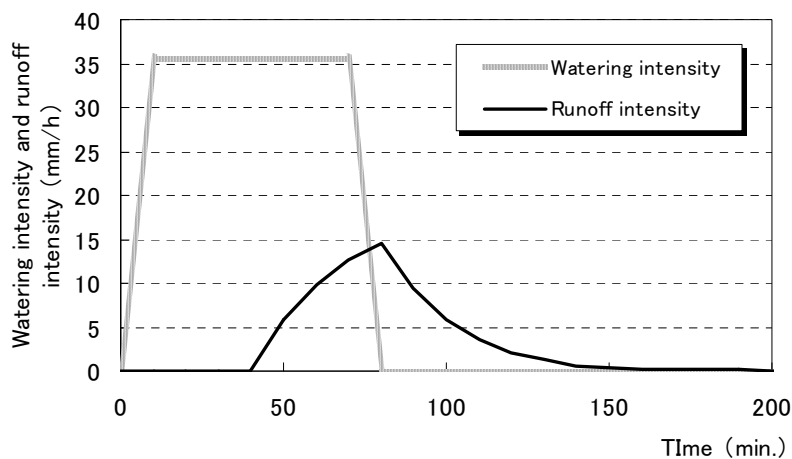
Figure 8 : Data on watering experiments measured at Section B

Experiments involving watering the test pavement were conducted, and the results obtained at Section B are shown in Figure 8 as an example. Rainwater mostly ran off through the drainage pipe installed on the subgrade upper surface, and no surface runoff on the roadways was observed. The water began draining through the drainage pipe after a delay from the start of watering, and the peak runoff volume turned out to be lower than the watering intensity. The same trend was observed at other test pavement sections where a drainage pipe had been installed, thereby proving the effectiveness of rainwater runoff control.

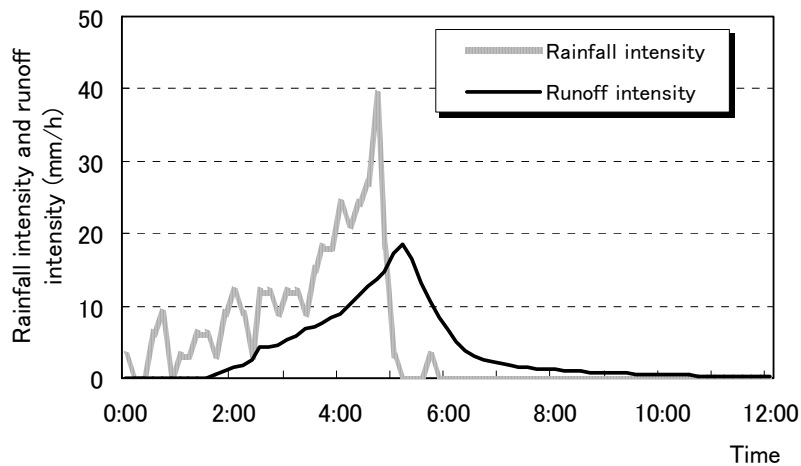
Figure 9 : Data on natural rainfall measured at Section A

Natural rainfall measurement was conducted, and the data obtained at Section A are shown in Figure 9 as an example. The rainfall peak was 39.0 mm/h observed at 4:40, whereas the runoff peak was 18.6 mm/h observed at 5:10, showing a 52% reduction in peak runoff volume from the peak rainwater volume. In addition, there was a delay of around 30 minutes in the peak runoff from the peak rainfall. The fact that the rainwater runs off after a delay and with a reduced volume from the peak rainfall helps mitigate the load to rivers and sewers, and so helps mitigate flooding in urban areas.

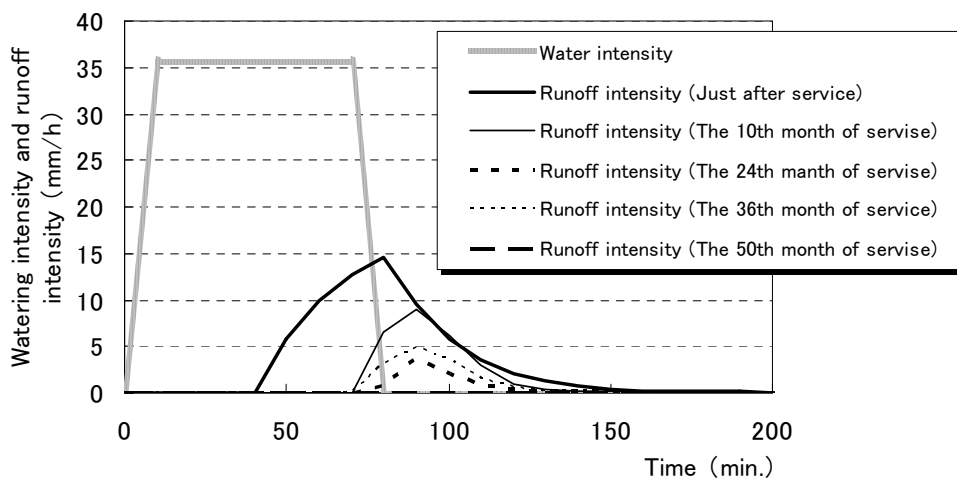
Figure 10 : Data on watering experiments measured at Section B

Figure 10 shows the results of watering experiments at Section B as an example. In a year after the road was opened to service, the peak runoff of 15 mm/h from the drainage pipe was measured, and the runoff from the drainage pipe then decreased in subsequent watering experiments. In the watering experiment conducted 50 months after the start of service, no runoff was measured from the drainage pipe.

Thus, no runoff was measured from the drainage pipe in the watering experiment conducted 50 months after the start of service at Section B, because water permeation through the road surface was blocked by the clogging of voids of the pavement. Moreover, the clogging of voids similar to Section B occurred at Section F and G. In this test construction, it was confirmed that several places where the runoff control performance declined in the fourth to fifth years of service.

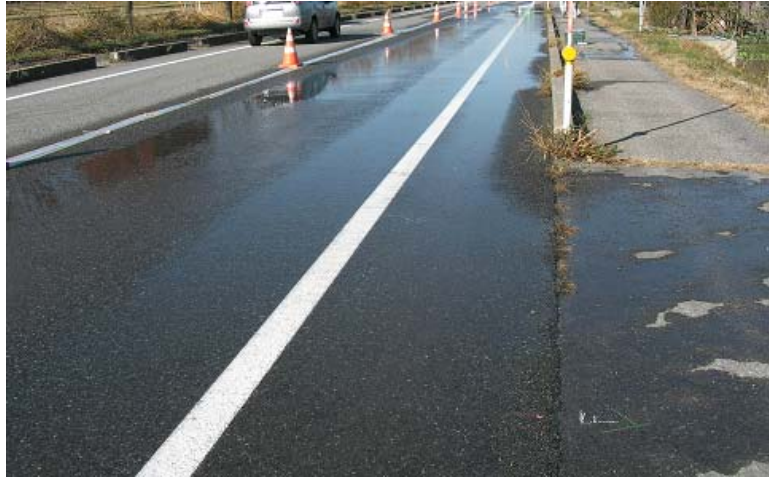
Photo 5 : Situation of the watering experiment after 50 months of service at Section B

Photo 5 shows the result of the watering experiment conducted 50 months after the start of service. As most of the sprinkled water overflows or remains stagnant on the road surface, it was considered that the water does not permeate through the pavement surface. In addition, it was visually confirmed that earth and sand accumulated in voids of the road surface.
