Thermal Imaging for Quality Control of Hot Mix Asphalt

M. Lavoie

Ministry of Transportation of Quebec, Quebec city, Quebec, Canada

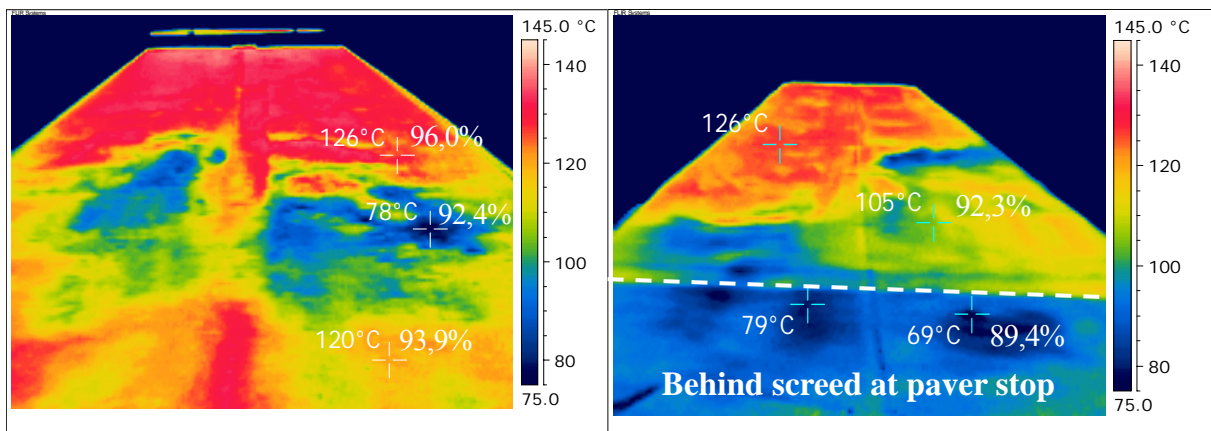
Figure 3: Thermal differentials resulting from complete emptying of hopper and paver stops

Other practices also have a negative effect on the uniformity of the texture and temperature of the HMA, including spilling asphalt in front of paver (Figure 2), emptying hopper wings and conveyors, and prolonged paver stops (Figure 3).

These results, which were measured at several work sites, occur cyclically, at intervals of between 15 m and 35 m, depending on strip width and lift thickness.

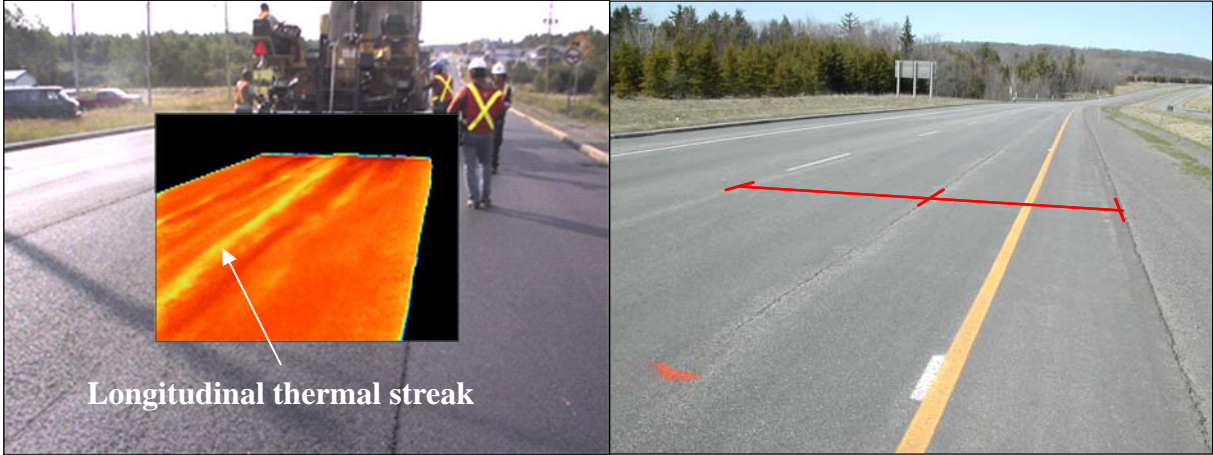
Figure 4: Longitudinal thermal streaks and cracking, usually occurring at centre of the strip

Another type of problem related to the issue of uniformity during lay-down operations is longitudinal (centerline) segregation located near the centre of the paver. Even though this type of failure is not always visible to the naked eye during placement, it can be detected using the infrared camera. These thermal streaks are associated with bad distribution of mix in the mat due to improper settings on the finishers and/or inadequate operating methods. They are the thermal signature of a discontinuity caused either by the presence of aggregate segregation or by a lack of mix (density variation), or a combination of both. Longitudinal thermal segregation shows up as a continuous rectilinear streak can be several on the same image in some cases. This very common deficiency represents an area of weakness with low

resistance to thermal contractions. It results in the development of a longitudinal crack near the center of the strip occurring in the first winters following the paving work (Figure 4).

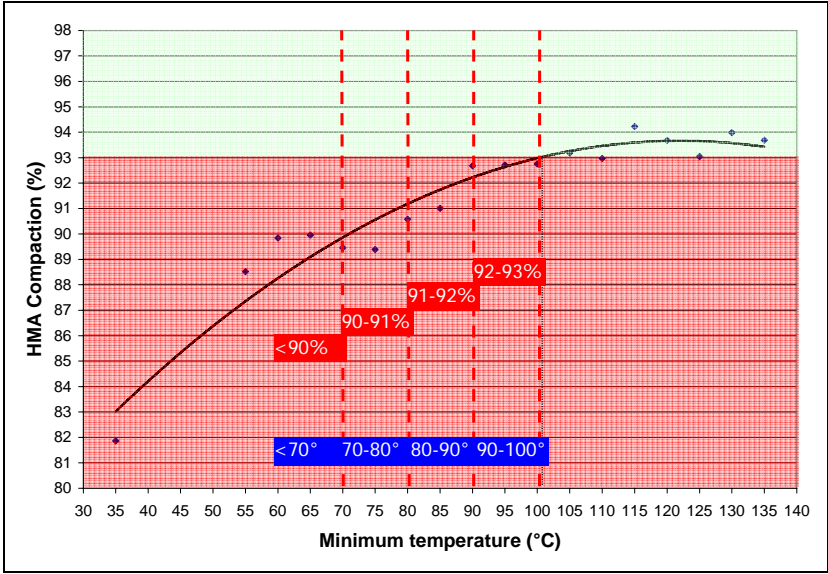
Figure 5: Correlation between compaction and minimum temperature of cold spots

In the study conducted in 2005, cold spots resulting from temperature heterogeneity were detected and located on worksites. A camera was used to take infrared images for temperature analyses. Almost 300 test areas distributed among 28 worksites were used to establish correlations between surface temperature and compaction, measured with a nuclear density gauge. The results show that compaction decreases as the temperature differential (ΔT°) increases, and that the 93.0% compaction required by the MTQ corresponds to a ΔT° of approximately 20°C. The compaction measured on cold spots is generally non-compliant (<93.0%) when the minimum surface temperature is below 100°C (Figure 5). These results are consistent with those obtained by other highway administrations, such as the Washington DOT (Willoughby *et al.* 2002).

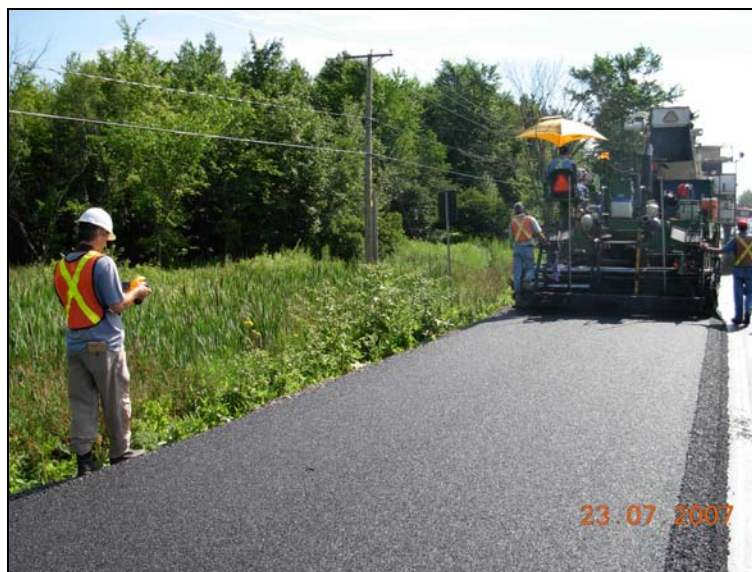
Figure 6: Position for taking temperature measurements behind a paver

The key aspect of the procedure at the worksite is to take temperature measurements behind a paver (Figure 6) when a truck is discharging (or on an equivalent volume, when an MTV is used).

When taking measurements, the camera operator takes up a position on one side of the freshly placed asphalt strip. He follows the paver as it moves forward and must remain within 10 meters of it. He must take as many images as necessary to cover the entire mat between him and the back of the paver screed. The rollers must not compact the measurement zone and should remain behind the camera operator while the measurements are taken. This operation is carried out once per 200 or 250-metric-ton lot depending on asphalt plant production rate in metrics ton per hour.

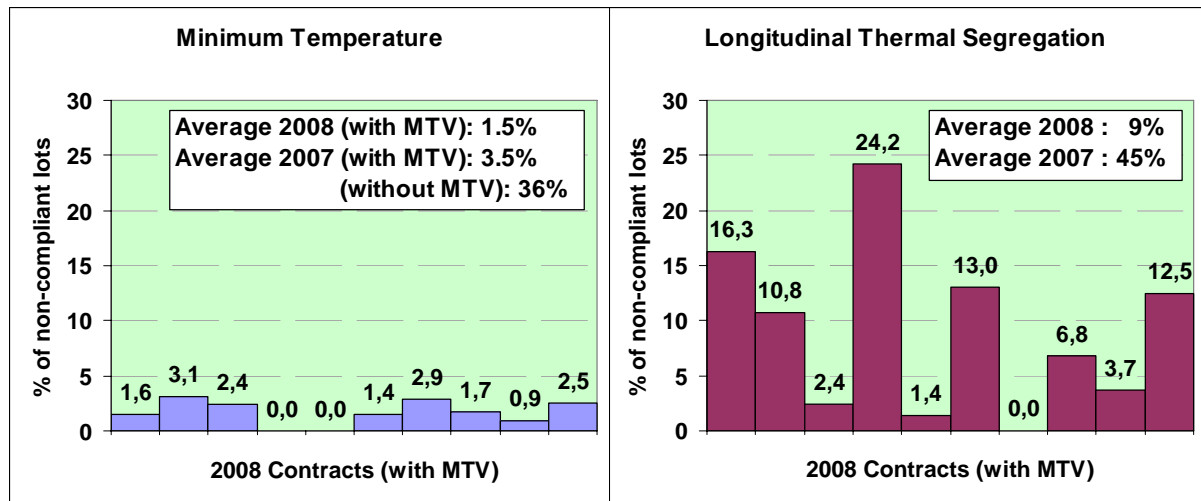
Figure 9: Results of non-compliant lots by contract for minimal temperature and longitudinal thermal segregation criteria

Proportions of non-compliant lots with regard to the minimal temperature criterion for all the 2008 contracts are summarized in Figure 9. MTVs helped contractors comply with this criterion more easily, as the results of 10 contracts carried out in 2008 show. Percentages varied from 0 to 3.1%, for an average of 1.5%. However, cold spots can be created if there are waiting times due to a lack of trucks or if hot mix is spilled on the surface in front of the finishers. In the 2007 pilot projects, the average percentage of non-compliant lots recorded was 3.5% with MTVs and 36% without MTVs. The maximum temperature criterion was respected for all lots of measurements, which is reassuring with regard to the risk of overheating of the HMA for the controlled contracts.

Proportions of non-compliant lots with regard to the longitudinal thermal segregation criterion for all the 2008 contracts are summarized in Figure 8. The results vary from 0 to 24.2 %, for an average of 9.4 %, which represents an improvement compared with 45% average obtained in 2007. As has been observed for several years, the use of MTVs has not eliminated this phenomenon. Steps contractors have taken to solve this problem have had positive results. The solutions they have implemented include maintenance of the finishers, addition of certain parts and modifications to operating methods (screed adjustments, augers height, speed, etc.).
