Implementation and validation of a new 3D automated pavement cracking measurement equipment

ABSTRACT: In order to maximise road maintenance funds and optimise the condition of road networks thus saving energy and valuable resources, pavement management systems need detailed and reliable data on the status of the road network. To date, reliable crack data has proven difficult and expensive to obtain. To solve this problem, over the last 7 years INO (National Optics Institute of Canada) in collaboration with the MTQ (Ministère des Transports du Québec) have been developing and testing a new technology called the LCMS (Laser Crack Measurement System). The LCMS is composed of two high performance 3D laser profilers that are able to measure complete transverse road profiles and to process this data using algorithms that automatically extract crack data including crack type (transverse, longitudinal, alligator) and severity. This system was completed in three main phases. The first (2002) aimed at evaluating the 3D laser profilers and was validated by surveying a road section containing artificial cracks created by saw cuts. The second phase validated the algorithms for the detection an

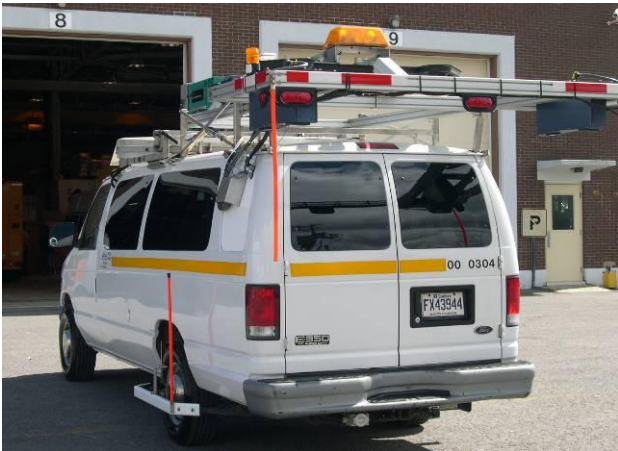
Figure 1: Photo of the LCMS on the MTQ Inspection Vehicle

The LCMS system is based on two high performance transverse 3D laser profilers that are placed at the rear of the inspection vehicle looking down in such a way as to scan the entire 4m width of the road surface (Laurent et al. 2008, Laurent and Hébert 2002). Figure 1 illustrates the system installed on the MTQ vehicle. The use of 3D laser profilers allows the system to directly measure surface defects such as cracks, ruts, potholes, macro-texture, joints and patches

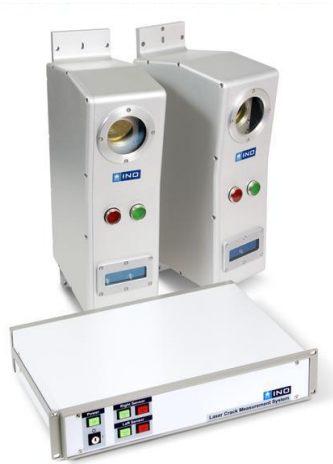
Figure 2: Photo of the LCMS System (Sensors and Controller)

while the intensity data that is also collected allows for the detection of lane markings and sealed cracks. Table 1 summarizes the specifications of the LCMS system and figure 2 shows a close-up picture of the sensors.

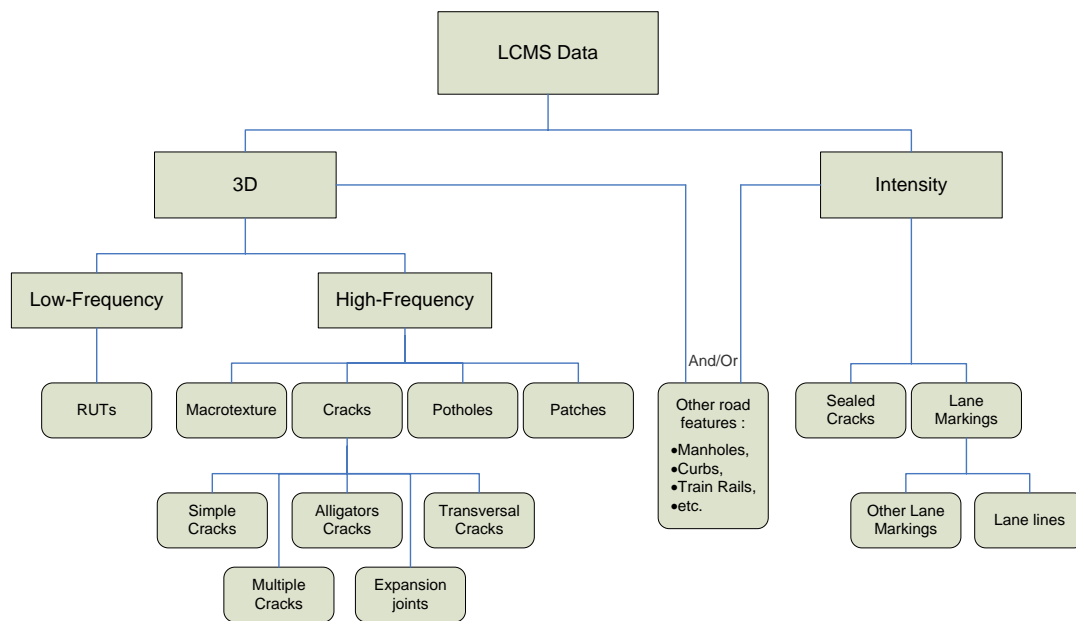
The sensors used with the LCMS system are 3D laser profilers that use high power laser line projectors, custom filters and a camera as the detector. The light stripe is projected onto the pavement and its image is captured by the camera. The shape of the pavement is acquired as the inspection vehicle travels along the road using a DMI signal from an odometer to synchronize the sensor acquisition. All the images coming from the cameras are sent to the frame grabber to be digitized and then processed by the CPU. Saving the raw images would imply storing nearly 30 Gb per kilometer at 100 km/h but using lossless data compression algorithms on the 3D data and fast JPEG compression on the intensity data brings the data rate down to a very manageable 20 Mb/s or 720 Mb per kilometer. The LCMS sensors simultaneously acquire both range and intensity profiles. On one hand, the range profiles give the 3D shape for a transversal portion of the road. On the other hand the intensity profiles are more or less a greyscale one dimensional image of the road. Figure 4 illustrates how the various types of data collected by the LCMS system can be exploited to characterize many types of road features. Figure 5 shows that the 3D data and Intensity data serve different purposes. The intensity data is required for the detection of lane markings and sealed cracks whereas the 3D data is used for most of the other features.

Figure 4: Data analysis library diagram

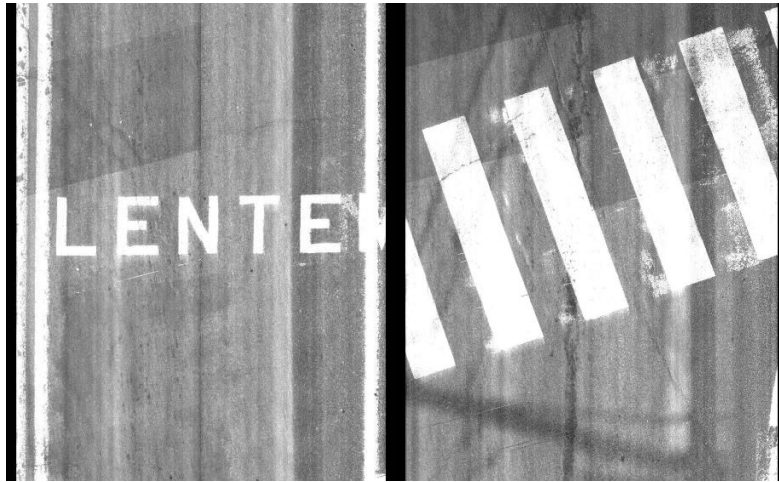
Intensity profiles provided by the LCMS are actually a continuous picture of the road. The first role of the intensity information is for the detection of road limits. This algorithm relies on the detection of the painted lines used as lane markings to determine the width and position of the road lane (see figure 5). The lane position data is then used by the other detection algorithms to circumscribe the analysis within this region of interest in order to avoid surveying defects outside the lane. Highly reflective painted landmarks are much easier to detect in 2D since they generally appear highly contrasted in the intensity images. With the proper pattern recognition algorithms, various markings can be identified and surveyed. To

date, only the detection of lane lines has been implemented and tested. In future work we will also be exploring the possibility of evaluating the ‘quality’ of the lane marking by computing deterioration as the ratio of the surface of the marking having lost its reflectivity. The following figure shows two intensity images with painted lane marks.

Figure 5: LCMS images of painted lane marks

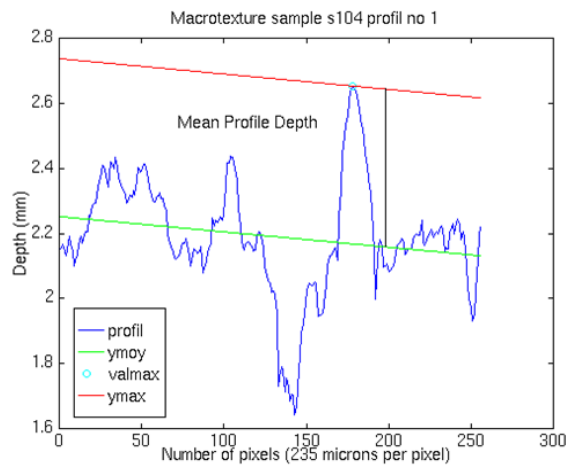
Macrotexture is important for several reasons, for example it can help estimate the tire/road friction level, water runoff and aquaplaning conditions and tire/road noise levels produced just to name these. Macrotexture can be evaluated by applying the ISO 13473 norm. This standard requires the calculation of the mean profile depth (MPD). To calculate the MPD, the profile is divided into small segments and for each segment a linear regression is performed on the data. The MPD is then computed as the difference between the highest point on the profile and the average fitted line for the considered portion. See figure 7 below.

Figure 7 : Macrotexture Analysis Example
