# Repair Method of Aged Reservoir and Irrigation Canal with Asphalt Panel

T.Watanabe

*Environment & Landscape Department of Seikitokyu Kogyo Co., Ltd, Tokyo, Japan*

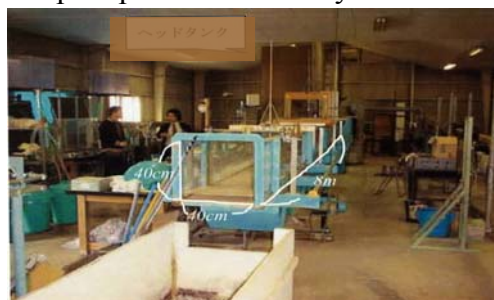
Photo 1: Experimental Measurement of Roughness Coefficient

The target value of roughness coefficient, n, is 0.013 (roughness coefficient for cast-in-place concrete) . The roughness coefficient of the asphalt panel in a laboratory test canal was 0.012 (Photo 1).

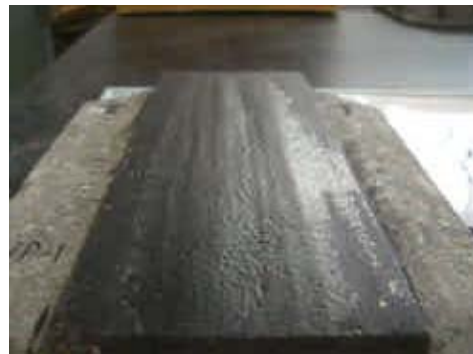
Photo 3: State of Specimen Abraded

One of the degradation phenomena peculiar to concrete irrigation canals is the abrasive action by running water and soil and sand included. Such selective abrasion results in the degradation in roughness coefficient and loss of coarse aggregate, which decreases the irrigation function and structural strength. In the present case, we measured the abrasion resistance of the asphalt panel by the selective abrasion test developed through the government-private sector joint research. The established test conditions are shown in Table 4. According to the test results, the abrasion loss of the asphalt panel was 1,019 mm<sup>3</sup>, 39% of the value of 2,634 mm<sup>3</sup> in the case of the JIS mortar. Therefore, the asphalt panel fully satisfies the target value. The test machine and sample are shown in Photo 2.

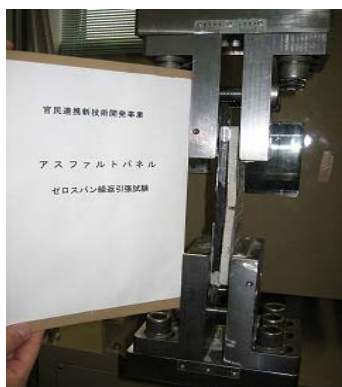
Photo 4: Zero-span Test under Way

In this paper, the opening and closing phenomenon which is severer condition than static expansion of the crack and joint is referred to as the “zero-span”. A soft material capable of responding to this phenomenon is called for. As to the zero-span phenomenon, we evaluated the repetition effect of the daily variation in an actual canal in addition to 3) Response to cracking. As a result of the repeated tensile test made under the test conditions of Table 5, no fracture was observed in any of the samples and

the ratio of decrease in tensile load was 70%. This is due to the viscoelasticity of the asphalt panel and it is effective against the response to zero-span.

Item	Test conditions
Section of specimen	Surface of mortar plate covered with asphalt panels
Test condition	Repeated tension, initial (0.2 mm ± 0.1mm)
Test temperature	Normal temperature
Evaluation method	No. of repetitions: 18,250 (365 days x 50 years) or more

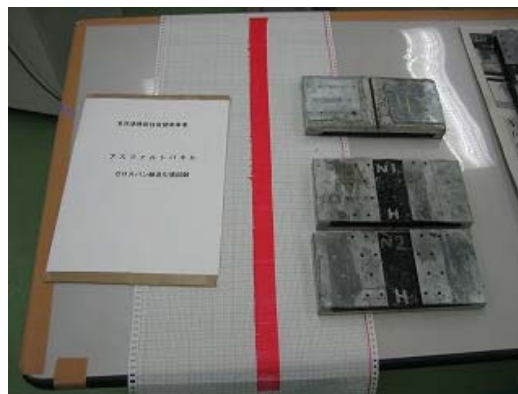
Photo 5: State of Specimen

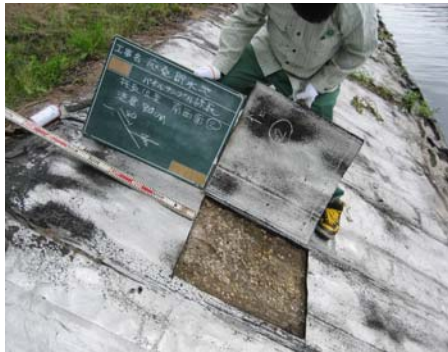
Photo 6: Sampling State

There are two types of weather resistance test methods, i.e., sunshine type and xenon type. Either of them is unsuitable for the asphalt panel having asphalt as the main component because its temperature becomes too high. Therefore, we took samples from the area having actually passed 37 years after construction and carried out the tensile strength test under the test conditions of Table 7. Consequently, the test results could be confirmed to be virtually equivalent to those of the test in 1966 as shown in Fig. 3.

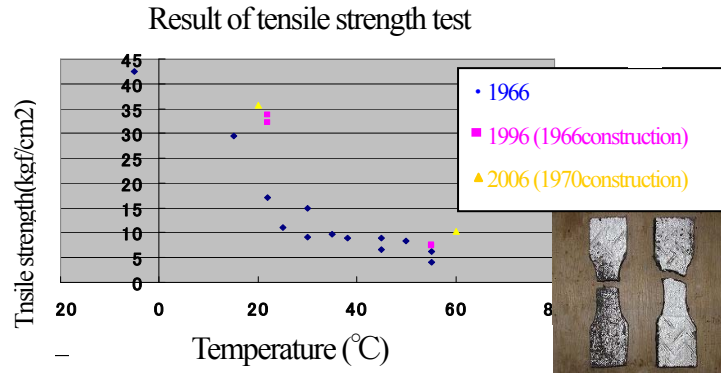
Figure 3: Results of Tensile Strength Test

Item	Test conditions
Year of sample fabrication	1966 (40 years ago)
Shape of specimen	Dumbbell-like
Test speed	10 mm/min
Test temperature	22°C, 55°C
Evaluation method	Tensile strength, deformation under max. load

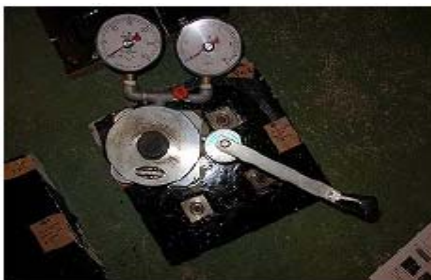
Photo 7: Bond Strength Test under Way

The bond strength test was carried out under the test conditions of Table 8. As a result, the bond strength was 0.94 N/mm<sup>2</sup> at 23°C and 1.49 N/mm<sup>2</sup> at 0°C as shown in Fig. 4.

Item	Test conditions
Test method	“Building Research Institute” type bond strength test machine
Shape of specimen	40 mm x 40 mm = 1,600 mm <sup>2</sup>
Test speed	1,500- 2,000 N/min
Test temperature	23°C, 0°C
Evaluation method	Bond strength: 0.7 N/mm <sup>2</sup> or more

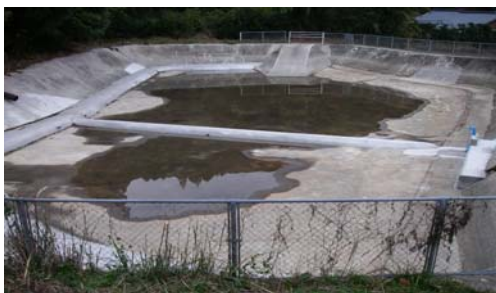
Photo 8: Before Work

This reservoir was constructed about 30 years ago. It was shielded by the “sealing-zone” method using clay and by covering the entire surface with 8 cm thick cast-in-place concrete. The concrete surface showed a number of small and large cracks and part of the embankment was leaky.

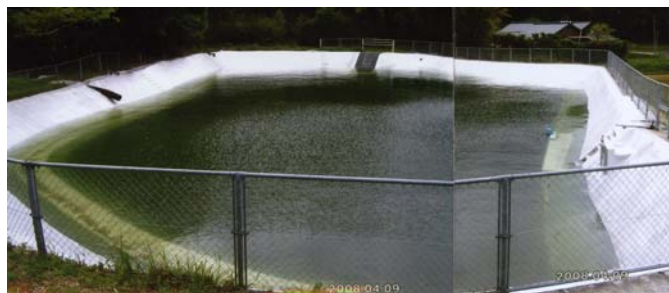
Photo 9: After Completion
