# Evaluation of Asphalt Deterioration Behavior Based on Ultraviolet ray Climate and Prediction in Accelerated Weathering Test

**ABSTRACT:** Asphalt deterioration is primarily the result of fatigue caused by repetitive traffic loadings and oxidation caused by solar heat and ultraviolet (UV) radiation. Damage from UV rays is especially significant because such radiation acts directly on the chemical linkage of the material, resulting in bond cutting and crosslinking that weakens the material. As a result, UV radiation is considered the primary cause of the top-down cracking and aggregate stripping of asphalt pavement. Despite this, there have been studies related to weather-based asphalt deterioration and it was not clear previously how meteorology-related deterioration influences pavement performance.

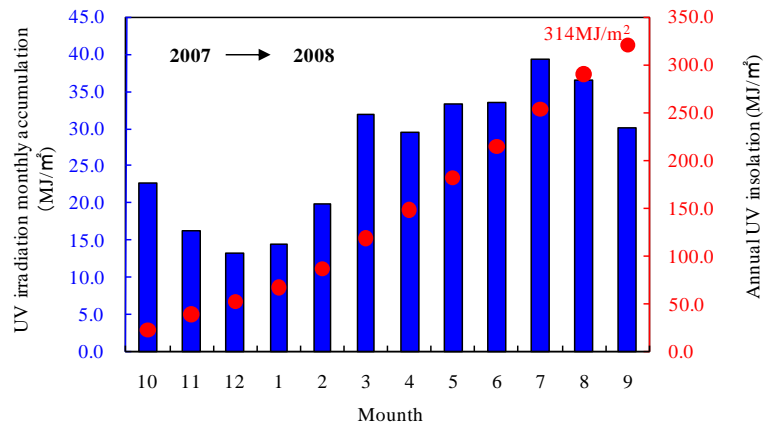
Meteorology conditions were observed with a thermometer, a precipitation gauge, and a radiometer that monitored the UV-A spectrum (315 – 400 nm). The monthly UV radiation data from October 2007 to September 2008 are shown in Figure 1. These observations indicated an annual UV insolation of 314 MJ/m<sup>2</sup>, a mean annual temperature of 17°C and an annual rainfall of 1348 mm.

Figure 1: The monthly and annual UV insolation data from Oct.2007 to Sep.2008.

- 1) In Tsukuba city, meteorological observations revealed that the annual UV irradiation was  $314 \text{ MJ/m}^2$ , the annual mean temperature was  $17^\circ\text{C}$ , and the annual rainfall was 1348 mm.
- 2) Accelerated weathering test conditions were set on the basis of these field climate observations, and allowed speedy predictions of the weathering of materials.
- 3) UV irradiation causes progressive oxidation of asphalt, resulting in embrittlement and a reduction in cracking resistance. Therefore, it is thought that cracking is predictable if the oxidation degradation is appreciable.
- 4) SBS, used as a modifier for asphalt, shows structural degradation due to UV exposure. As a result, it can be expected that peculiar elasticity of the butadiene will be lost.

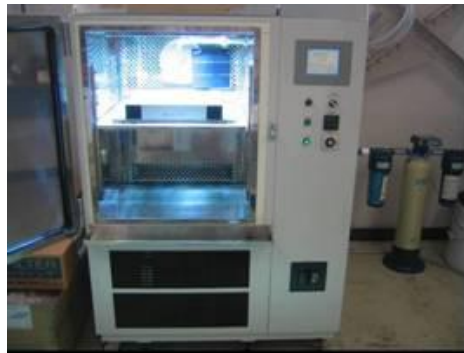
An accelerated weathering meter was employed to conduct short-term examinations of the influence of weather load on asphalt (Photo 2).

Photo 2: Accelerated weathering meter

The conditions for the accelerated weathering test were set on the basis of observed meteorology data. The conditions used are listed in Table 2. The intensity of the light source was adjusted to provide 324 MJ/m<sup>2</sup> of annual UV insolation, equivalent to a year's exposure (UV insolation observed data; 314MJ/m<sup>2</sup>) under the sun, within 200 hours.

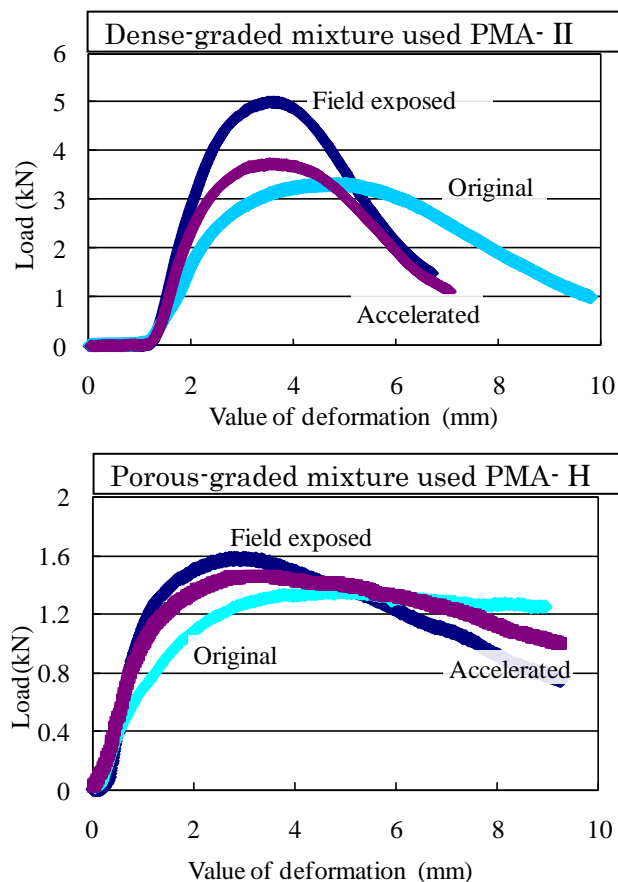
The results of the bending tests are shown in Figure 4. Changes in the maximum load and displacement at maximum bending load were found in the exposed and accelerated specimens. Specimens exposed to field climate conditions and subjected to the accelerated weathering test showed identical trends in flexibility, even when their maximum strengths differed.

Figure 4: The results of bending test (Dense-graded and Porous-graded mixture).

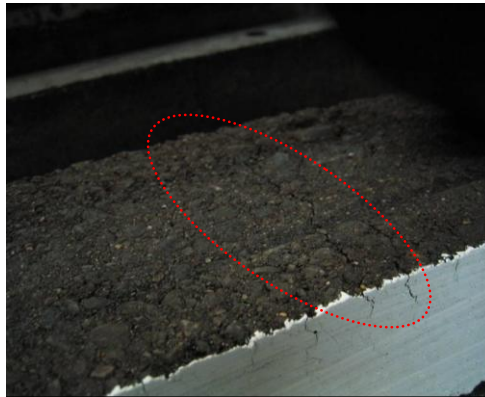
Photo 4: Cracking occurred in mixture surface (Dense-graded mixture used PMA- II).

The results of observations made during the wheel-tracking fatigue tests are shown in Photo 4. Cracking occurred in locations that developed a grainy texture due to the meteorological load just after the wheel-tracking test and in places where the mortar had flaked away. The cracks subsequently increased to depths of 1cm. Meanwhile, almost no cracks developed in the new mixture. These results indicate that a change had occurred in the condition of the asphalt mixture at the surface due to the meteorological load.

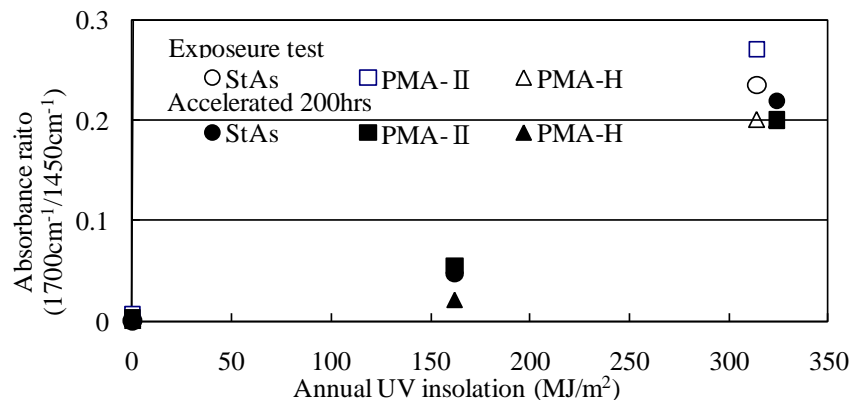
The results of infrared spectroscopy on recovered asphalt are shown in Figure 5. There were some differences between the samples exposed to field climate conditions and the samples subjected to accelerated weathering test, but, overall, oxidation degradation was noted to progress with increased UV irradiation. These findings confirm that we can determine their serviceability in shorter periods of time compared to natural degradation.

Figure 5: Infrared spectroscopy results of the carbonyl absorbance ratio ( $1700\text{cm}^{-1}/1450\text{cm}^{-1}$ ).

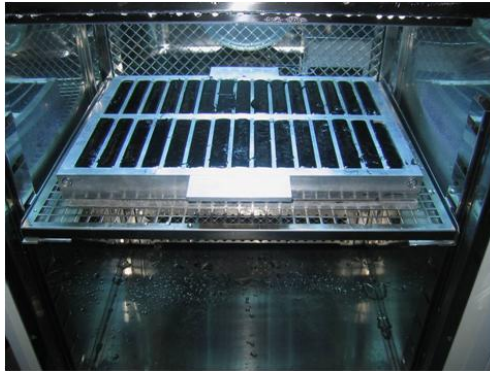
Specimens were made from each of the binders shown in Table 1 measuring  $2 \times 2 \times 12$ cm and subjected to the accelerated weathering test. The test setup is shown in Photo 5.

Photo 5: Binder specimen for accelerated weathering test.

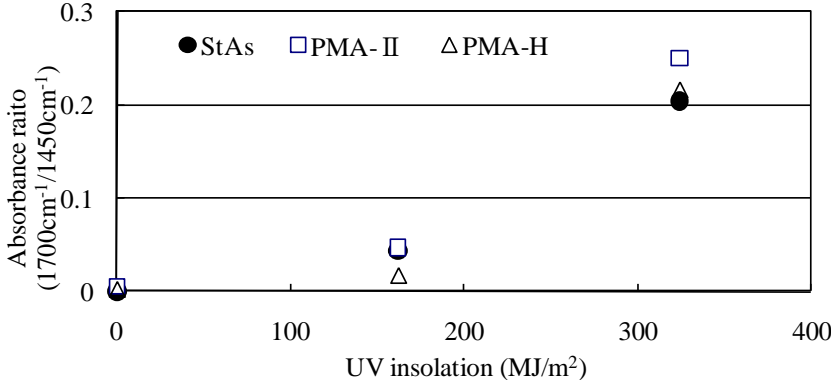
Infrared spectroscopy results for binder specimens are shown in Figure 8.

Figure 8: Infrared spectroscopy results of the carbonyl absorbance ratio.

As already seen in the mixture, an increase in the carbonyl peak was found with respect to the amount of UV irradiation. This is similar to the results found in recovered asphalt 1.5 cm beneath the surface of the mixture following UV exposure of 314 MJ/m<sup>2</sup>, an amount equivalent to annual UV irradiation.

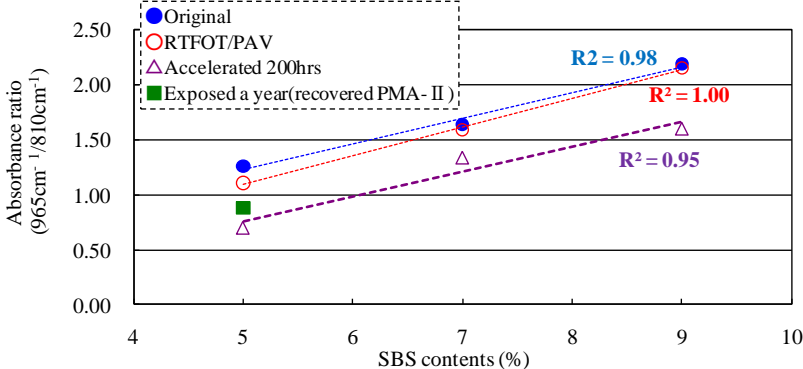
Working Curve, results of SBS-modified asphalt are shown in Figure 9.

Figure 9: Working curves of butadiene double-bond absorbance by Infrared spectroscopy.

A large drop in the absorbance ratio was found from the initially detected value in SBS-modified asphalt that had been subjected to accelerated weathering. There was almost no difference between these observations and observations of specimens prepared with RTFO/PAV. Therefore, it is sure that SBS molecular structures are greatly affected by the meteorological load, especially UV radiation. Since these findings showed a trend resembling the results from PMA-II recovered from the surfaces of specimens exposed to field climate conditions, it is possible to predict binder weathering using short and simple accelerated weathering tests.
