Typical Distress of Drainage Asphalt Pavement in Japan

K. Kubo, T. Ayabe

Public Works Research Institute, Tsukuba, Ibaraki, Japan

ABSTRACT: The first Drainage asphalt pavement (DAP) was constructed in 1987 in Tokyo, and now more than 60% of expressways have been paved by drainage asphalt pavement. The merits of DAP are improvement of traffic safety in rainy days and reduction of traffic noise. Through our 20 year experience, we have found numerous pavement failures, which are peculiar to DAP and do not occur in conventional asphalt pavements such as dense-graded asphalt concrete. In particular, the mechanism of lateral flow deformation, which occurs relatively earlier after open service, is not clear. This paper examines the causes of these lateral flow deformations found that this deformation is attributable to the characteristics of binder course asphalt concrete against plastic flow, the adhesion between surface and binder course, and the imperviousness of the binder course. Finally, countermeasures against these early distresses were proposed.

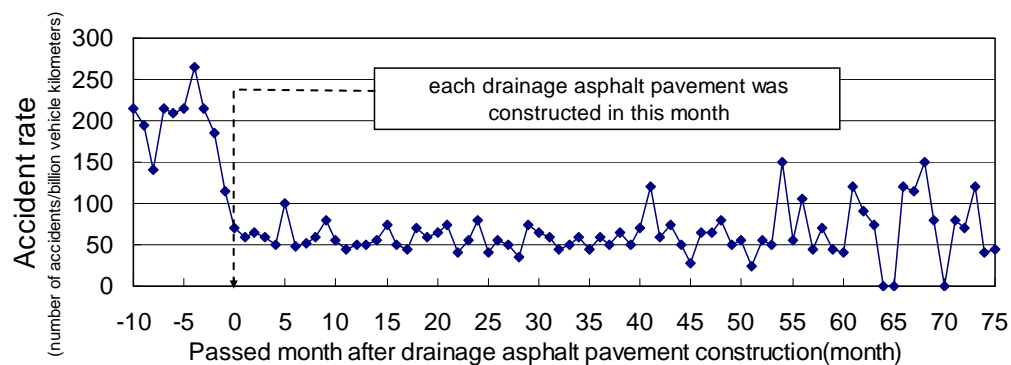
In Japan, the DAPs are popularly used in national highways and expressways. They are expected to reduce traffic noise especially in urban areas and also to reduce the number of traffic accidents especially in expressways. Figure1 shows the relation between accident rate and passed months after DAP construction in expressways. In this figure, accident rate means the possible number of traffic accidents while 1 million vehicles travel 1 hundred km. The number of traffic accidents decreased sharply after the construction of DAPs. For this traffic safety effect, more than 60% of expressways are paved by DAP in Japan.

Figure1: Accident rate and passed month after drainage pavement construction.

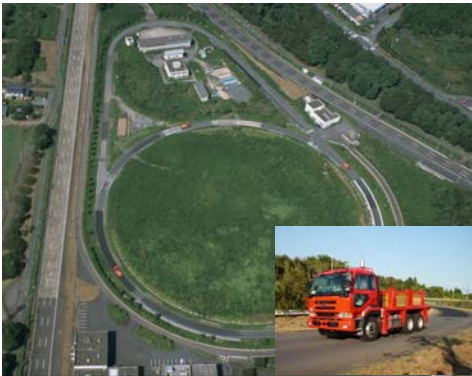
The early lateral flow was estimated to be caused by water permeated into pavement. In order to simulate this lateral flow, accelerated loading test was conducted as shown in Photo 1 (Kawakami 2008, Kubo 2008). Usually test pavements are constructed newly in full depth, however, for this simulation test pavement was constructed by milling existing pavement and overlaying new porous asphalt concrete at its surface layer.

Photo1: Pavement Test Field and Loading Vehicle

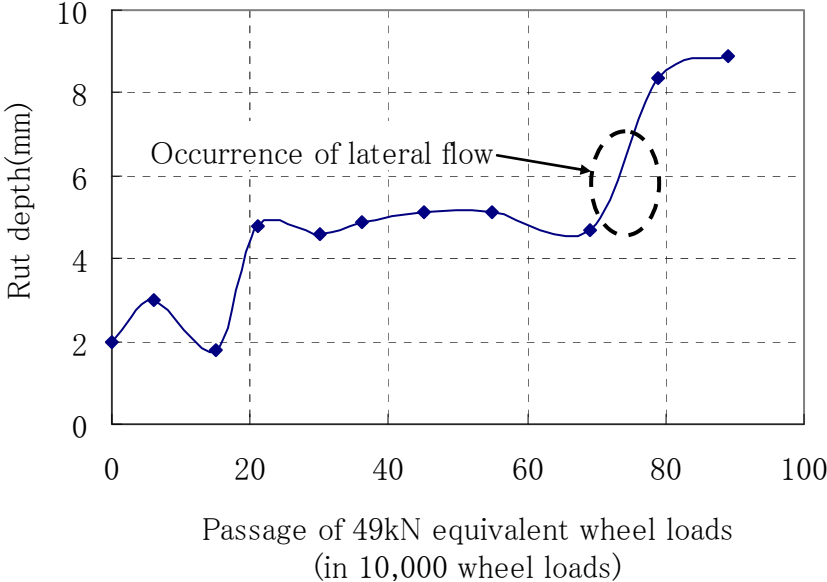
Figure 2 shows the test result. X axle shows the number of 49kN equivalent wheel loads which is based on the same concept of ESALs. After 700 thousands wheels had passed, the rutting depth had become sharply large, and this could be estimated to be caused by lateral flow.

Figure 2: Monitored rut depth in the accelerated loading test

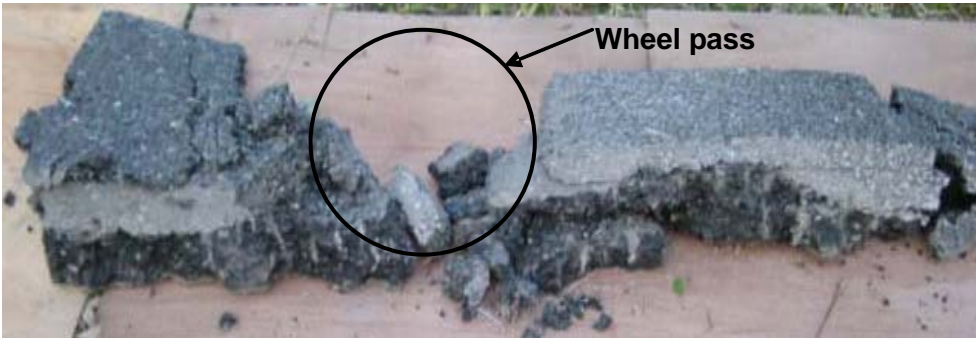
Photo 2 shows the cut specimen of surface and binder course after loading test. Heavy lateral flow was found in both surface and binder layer at wheel pass. These lateral flow were seemed to be caused by insufficient adhesion between surface and binder course, aggregate stripping in binder course, and layer separation due to stagnant water. Figure3 shows the concept of lateral flow occurrence.

Photo2 Cut specimen after accelerated loading test
