A Study about the Environmental Safeguard that Utilized Permeable Pavement

H. Asano, K. Yokoyama, Y. Ozeki, H. Okamoto
Aichi Prefectural Government, Nagoya, Aichi, Japan

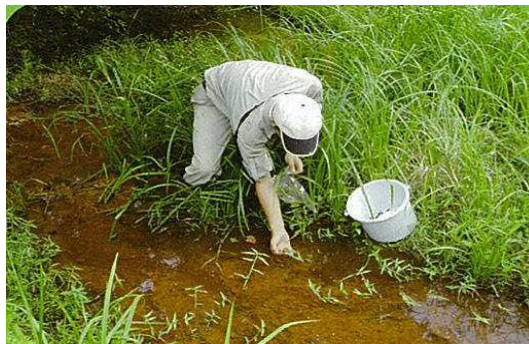
When constructing the main road, the flora and fauna in the area were surveyed in order to identify strategies that might mitigate the negative impacts on them. Rare species within the road construction site and areas that might be affected by the construction works were temporarily transplanted or relocated to safe areas in advance of construction.

Figure 1: Transplanting rare species to a temporary refuge

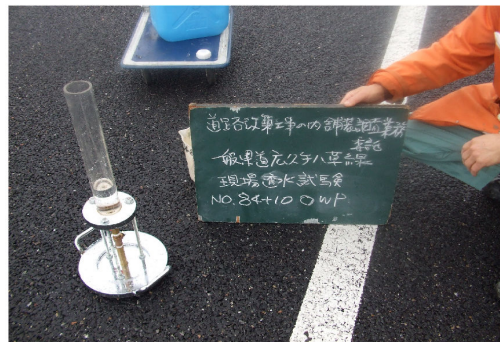
- Clean the pavement surface.
- Form a quantity of greasy clay into a 'snake' of about 1 cm diameter and 50 cm long. Affix it as a ring around the outer edge of the bottom of the base plate of the permeability test device (Fig. 6) to form a gasket or 'O-ring'. Press the test device down against the road surface firmly to ensure that there will be no water leakage through the clay gasket. Place a doughnut-shaped weight on the base plate to hold the device in place.
- Step 1: Place the mark “X1” at 100 mL from the top of the measuring cylinder, and place the mark “X2” at a position equivalent to 400 mL below the first mark.
- Step 2: Close the valve and fill the cylinder full of water.
- Step 3: Open the valve fully. Measure time for the water level in the cylindrical part to drop from the X1 level to the X2 level by a stop watch.
- Repeat steps 1 to 3 three times.

Figure 5: In-situ permeability test

To investigate the changes in permeability of the pavement with age, we conducted in-situ permeability tests on the Satoyama access road immediately after construction and 1, 3, and 4 years after construction using the testing method specified in the “Pavement Test Handbook” published by the Japan Highway Association. (unit : mL/15 s, target permeability : 400 mL/15 s)

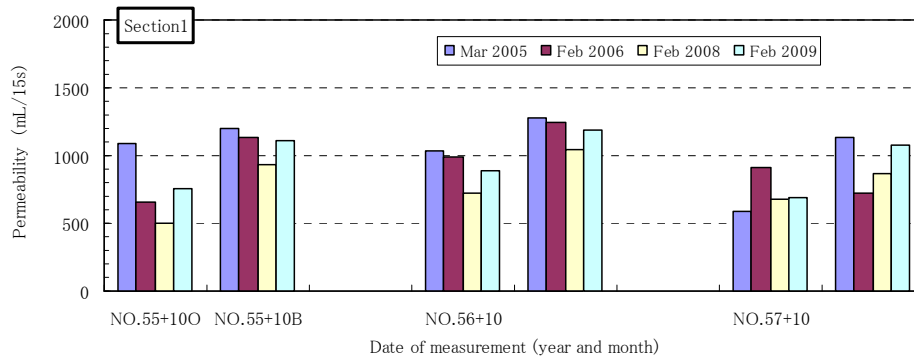
The in-situ permeability test results and permeability coefficients derived from the data by simple calculation are shown in Table 1. Figures 7 and 8 show the changes in in-situ permeability with age.

Four years after construction of the road (in February 2009), the average permeability from the 12 observation points was 1049 mL/15 s (690–1285 mL/15 s). These values were 91% (69–116%) of those measured immediately after construction. That is, the permeability of this pavement had declined by only 9% on average.

Figure 7: Changes in the in-situ permeability test results with age (Section 1)

The test results confirmed that the permeability performance of this pavement satisfied the target permeability value of 400 mL/15 s. Generally, pavement permeability is considered to deteriorate with age. However, the test results obtained over a period of 4 years from construction indicated that the permeability function of this pavement may have even improved slightly. This result may have been influenced by light rain early on the day of the test, but the rain would have had little influence on the permeability itself. Therefore, the test results indicate that the permeability function of this pavement persisted through the 4-year monitoring period after construction and maintained its required level of performance.

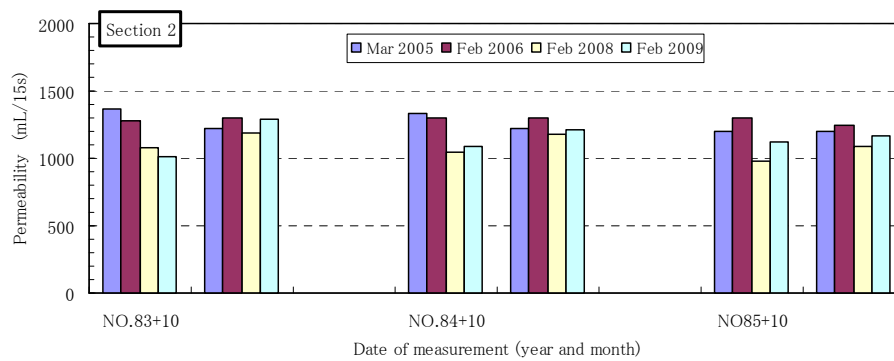
Even at the observation point from which the lowest permeability value was obtained (No. 57), the average permeability value from the outer wheel path (OWP) position and the between wheel path (BWP) position was approximately 800 mL/15 s. Although the permeability of this observation point had deteriorated in the 4 years since construction, the value satisfied the target permeability of 400 mL/15 s.

Figure 8: Changes in the in-situ permeability test results with age (Section 2)
