Development and Field Application of Slurried-Cement Foamed Asphalt (SCFA) Stabilization

Technical Research Institute, Kajima road Co., Ltd., Chofu, Tokyo, Japan

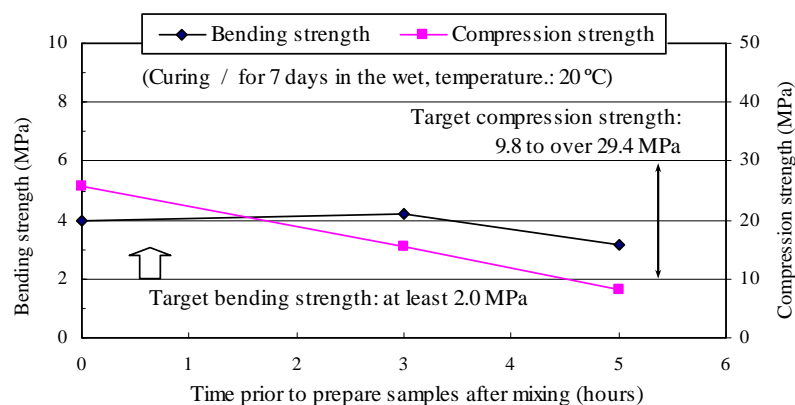
Figure 1: Changes in strength for slurried cement prepared at different time after mixing.

Changes in strength of slurried cement alone were investigated by conducting bending and compression strength tests (strength after 7 days of curing, in conformity with JIS R5201) on 3 specimens (ratio of water to cement (W/C) = 60%) prepared 0, 3, and 5 hours after mixing respectively. As shown in Figure 1, the bending strength satisfied the target value of 2.0 MPa at all hours, but the compression strength dropped by leaving the slurry long after mixing and fell below the target value at 5 hours after mixing.

Thus, the working time of slurried cement was estimated to be about 4 hours from the viewpoint of strength although the time may vary by the conditions of the site. The flow value (P funnel) at 4 hours was about 12 seconds, showing satisfactory flowability. Then the mix proportion of SCFA stabilized base mixture was designed using materials of common grain sizes and following the Pavement Recycling Handbook (JRA 2004). Changes in unconfined compression strength and air void of SCFA mixture specimens that were left (until compaction) for different times after mixing are shown in Figure 2. The strength decreased and air void increased as the mixture was left longer, but the specimen left for about 5 hours was found to satisfy the target value.

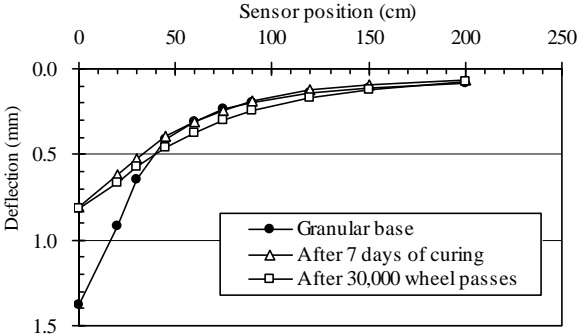
Figure 5: Deflection curves after crushing, 7 days of curing and 30,000 wheel passes.

The deflection curves at each step determined at the center of the yard with a falling weight deflectometer (FWD) are shown in Figure 5. The deflection values at each sensor position are the means of the values at two measurement points after correcting into values for the standard load (49 kN).

The figure shows that stabilization of the granular base decreased deflections within a range of 30 cm from the centre of the loading plate, showing improved rigidity of the base course. Deflection after 30,000 wheel passes was similar to that soon after construction, showing that the bearing capacity did not drop.

The modulus of elasticity of each layer was determined by conducting back-calculation (BALM 99) of a two-layer model (25 cm base course and subgrade). Using Equation (1), which is a modification of the equation (AASHTO 1986) for calculating the layer equivalency factor a_i of AASHTO so as to agree with the actual conditions in Japan, a_i was estimated for the base courses. The results are shown in Table 1.

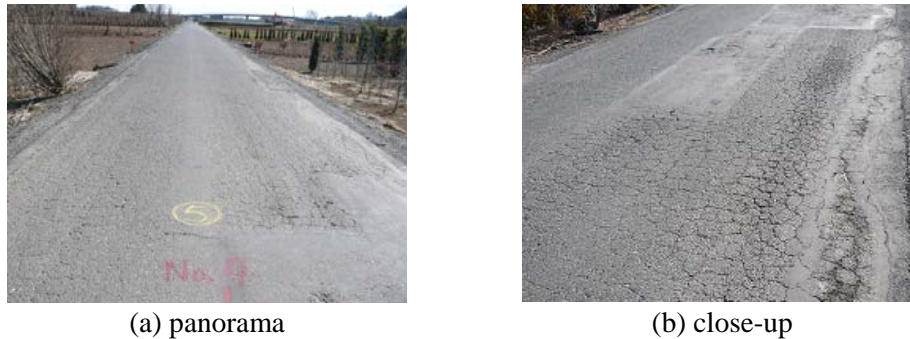
Figure 6: Typical surface condition ((a) panorama, (b) close-up).

As shown in Figure 6, alligator cracks had developed throughout the entire section, where many patches were also observed. The smoothness (σ_{3m} : standard deviation of unevenness at

1.5 m intervals) was about 4 mm and required repairing.

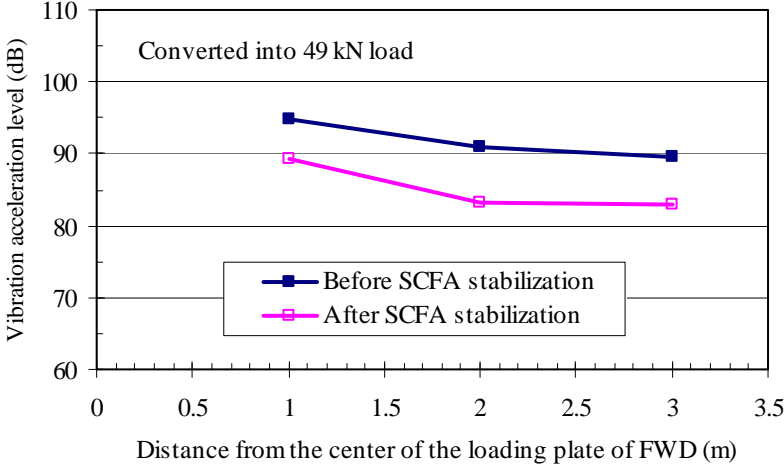
Figure 13: Vibration acceleration level in FWD (49 kN loading).

The load and vibration acceleration (peak value) were measured before and after SCFA stabilization while applying load with FWD, and the values before and after the stabilization were compared by converting the values into vibration acceleration values for the standard load of 49 kN. The results are shown in Figure 13.

As shown in the figure, the vibration acceleration levels were 5 to 8 dB smaller after the SCFA stabilization than before the stabilization regardless of distances between the vibration source and vibration detector. This showed that the improvement of the bearing capacity of pavement was effective for reducing vibration. Traffic vibration is the vibration of the ground caused by vehicles traveling on roads and is known to be affected by level differences and smoothness of the road surface (Iwasaki et al. 1977). Total evaluation will be needed by also taking these effects into account.
