# Winter problems with Porous Asphalt in the Netherlands

**ABSTRACT:** Since 1987 Porous Asphalt (PA) is applied on Dutch motorways, firstly because of safety reasons but since 1990 noise reduction was the main reason.

In this paper possible causes of frost damage in PA will be discussed and recommendations will be given to reduce frost damage as much as possible.

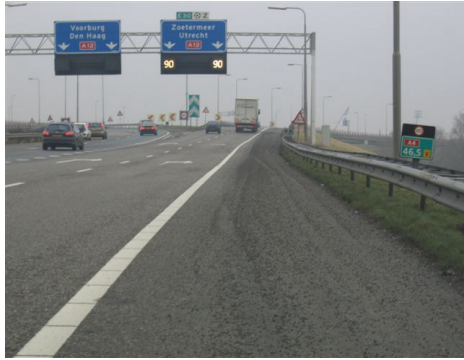
Figure 2: Example of severe raveling

During the frost period of January 2009 and the frost/thaw cycles afterwards more frost damage was observed on some locations of the Dutch motorway network than usual. The frost damage occurred in all types of wearing courses, but was extremely concentrated in PA. Wearing courses like DAC, SMA and emulsion asphalt concrete had experienced mostly potholes as frost damage and especially old PA road sections showed severe raveling, potholes (not deeper than 50 mm) and open longitudinal joints. In figures 2, 3, 4 and 5 examples are given of such frost damage in PA.

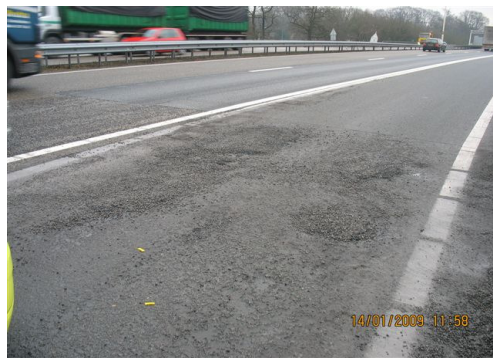
Figure 3: Difference in raveling new/old PA

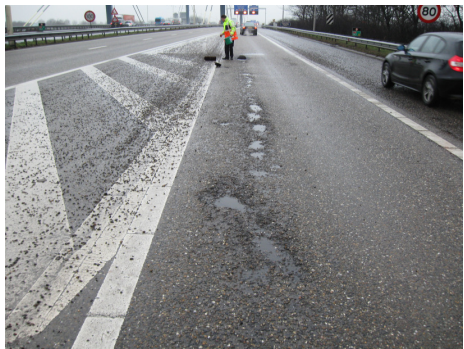
Figure 4: Example of potholes in PA.

Potholes can be filled with cold asphalt or hot mastic asphalt mixtures. The cold mixtures are less durable in comparison with the hot repairs, but are always available and easy in use. In the winter 2009/2009 the road administration decided in some cases not to repair the PA road sections with severe raveling, because laying of new PA below the freezing point will result in poor quality of PA. Also the contractors wouldn't give any guarantee. Because of safety reasons the road administration decided to mill off carriageway wide the whole damaged PA wearing course. The traffic had to drive on milled asphalt with a speed limitation of 90 km/h (normally 120 km/h is allowed) until the weather conditions permit to lay new PA again. This caused congestion, but no unsafe situation.

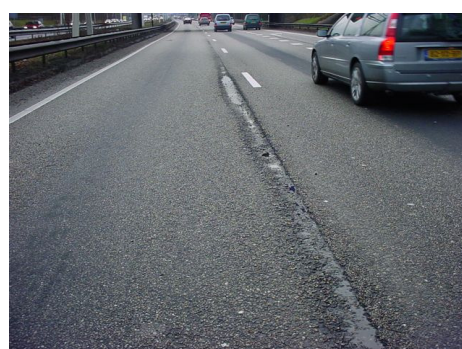
Figure 5: Example of an open longitudinal joint

Open longitudinal joints were temporary filled with cold or hot asphalt until the weather conditions were good to repair them durable.

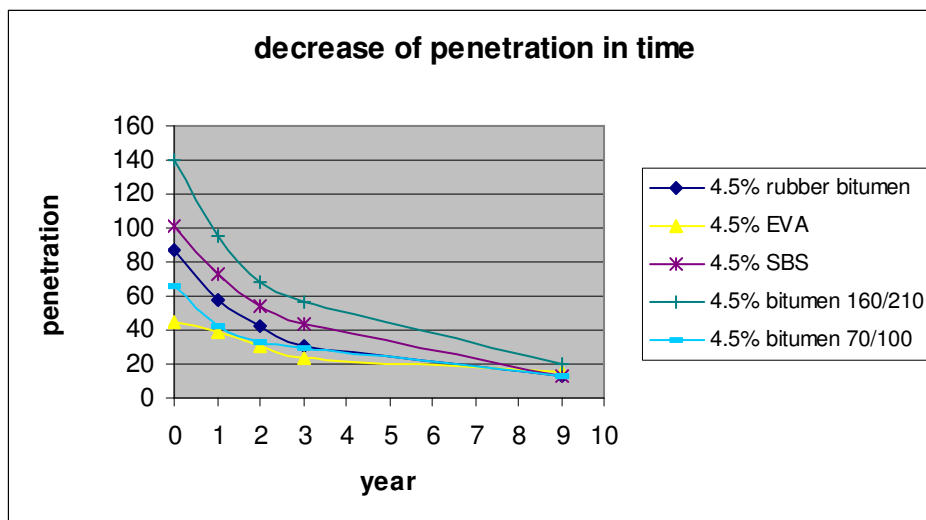
In (Voskuilen et al, 2004) the decrease in penetration in time of recovered bitumen from several PA test sites was given. Besides the standard pen grade 70/100 bitumen also PA test sites were investigated with rubber bitumen, EVA and SBS modified PMB's and a softer pen grade bitumen 160/210. In figure 6 an example is given of the results of the PA test sites with 4.5% binder on 100% aggregate (= 4.2% in the mixture). The PA test sites with 5.2% binder in the mixture gave approximately the same results. From figure 6 can be seen that all bitumens harden strongly the first 3 years and have almost the same penetration after 9 years in service.

Figure 6: Change of bitumen penetration in time.

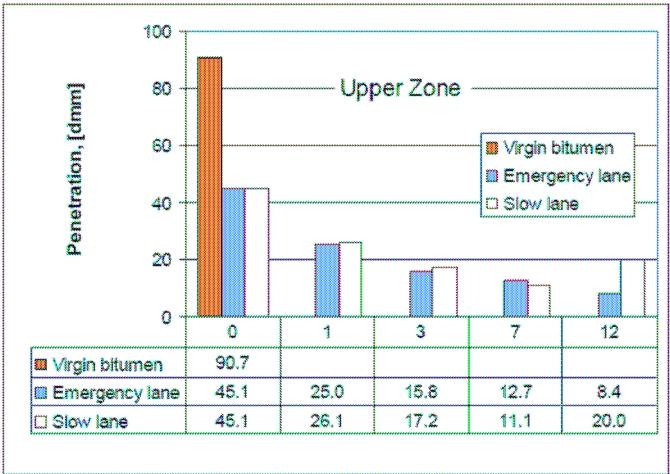
In figure 8 (Hagos, 2008) is shown that the ageing of the upper zone is more severe than ageing of the binder in the whole layer thickness. For this test the cores of 50 mm thick were horizontally cut in two equal parts and only the bitumen of the upper part was recovered for testing.

Figure 8: Change in penetration of bitumen recovered from field cores up till 12 years.

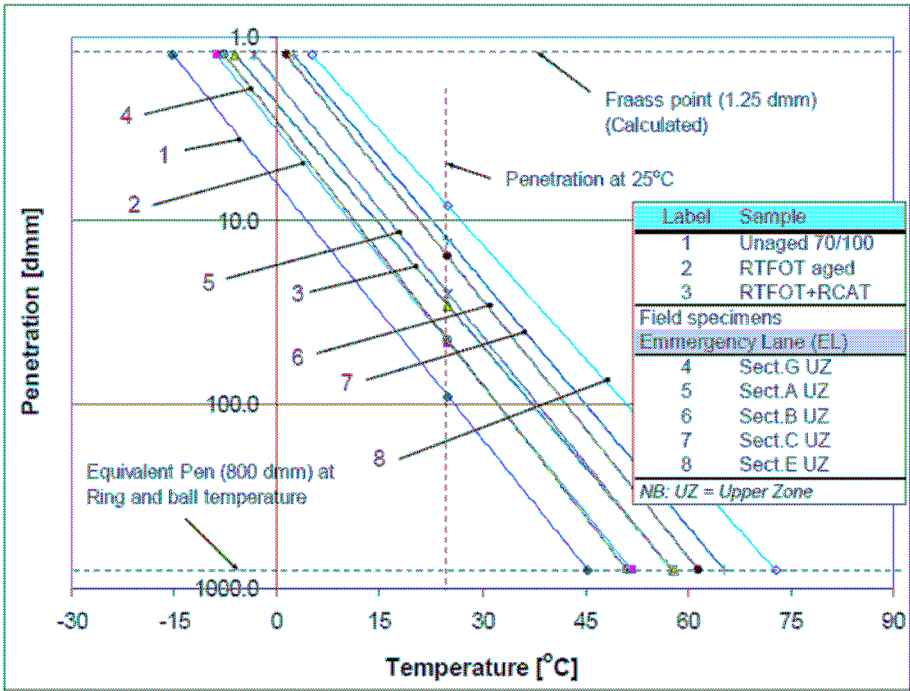
The effect of ageing on the temperature dependency of the laboratory aged and field binders from the emergency lane is nicely shown in figure 9. A horizontal shift in the temperature dependency of the properties can be observed, which suggests a higher temperature at which the bitumen becomes brittle.

Figure 9: Penetration of Lab aged material compared with field-aged bitumen compared in the BTDC

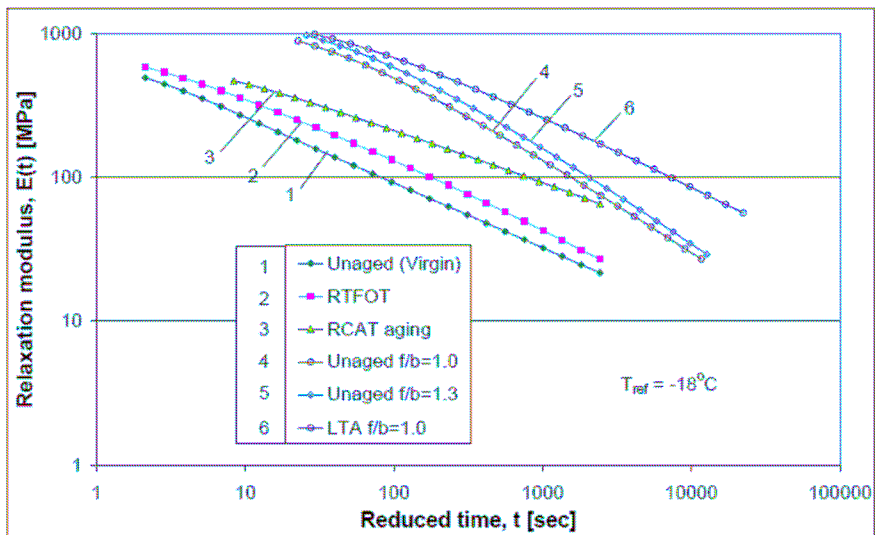
The consequence can also be shown with the predicted relaxation modulus from Bending Beam Rheometer (BBM) stiffness data at a reference temperature of -18 C as shown in figure 10. The relaxation behavior of the bitumen and the mortar is similar to the stiffness behavior. This means that at higher relaxation modulus it takes longer to relax stresses. Consequence is that (thermal) stresses stay longer in the material, causing the material to crack.

Figure 10: The relaxation behavior of the bitumen
