# Comparison of Asphalt and Concrete Pavement from the Aspect of Vehicle Vibration

**ABSTRACT:** Since it is not possible to build perfectly smooth pavements, paving specifications usually prescribe the maximum acceptable roughness. Irregularities of road surface cause number of problems to their users, including poor ride quality, unsafe driving conditions and excitation of truck dynamics leading to further pavement deterioration as well as damage to vehicles and cargo. This fact is very interesting if we compare different types of pavement structures. This paper discusses asphalt and concrete pavement through vehicle vibrations which are the main indicator of ride comfort. Measurements of vibrations, while driving over asphalt and concrete pavement, were taken on highway Zagreb-Slavonski Brod (Croatia). Vehicle vibrations were measured with different speed from 80 to 130 km/h on both pavements. Prior to vibrations recordings, measurement of the road surface roughness (IRI index) on asphalt and concrete pavement has been performed. Based on the obtained research results, the relationship between the roughness, type of pavement, vehicle speed and vibration of vehicles has been est

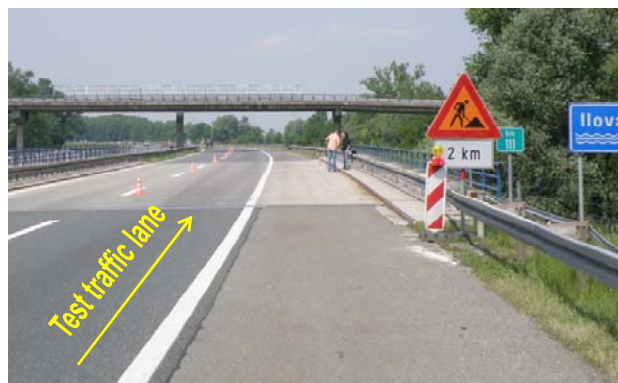
Figure 2a: Presentation of the location for vehicle vibrations test

Vehicle vibrations were recorded on a motorway traffic lane in 14 passages of a car at various speeds, from 80 km/h to 130 km/h. In order to ensure constant speed, not only on the bridge, but at least 60 to 70 m before and after the bridge, Croatian Motorways provided a test section with traffic signalization. Figure 2a shows the test location with the installed traffic signalization and Figure 2b shows schematic view of test section on Zagreb-Slavonski Brod Motorway.

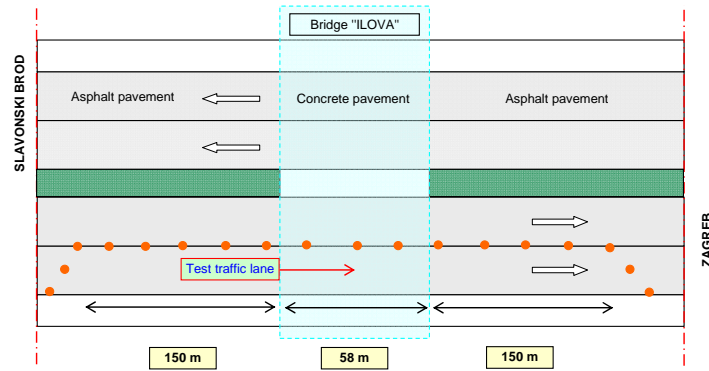
Figure 2b: Schematic view of test section on Zagreb-Slavonski Brod Motorway

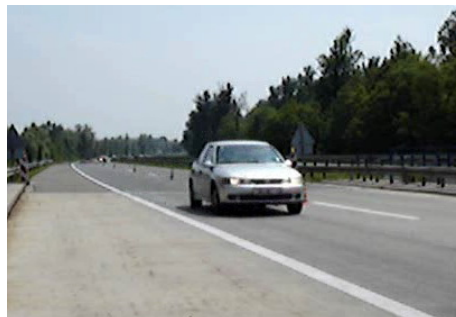
Figure 4: Test vehicle during the measurement of vibration on asphalt and concrete pavements

For the investigation of vehicle vibrations, personal car OPEL Vectra 1.8 1.6V comfort, equipped with summer tires 'Michelin Energy, 195/65 R15', regularly maintained (serviced at every 15000 km), having passed totally 130000 km, was used. OPEL is the German subsidiary of General Motors. In the United Kingdom, it is known as a Vauxhall and as a Holden in Australasia. Figure 4 shows the vehicle 'Opel Vectra' on the test section during the measurement of vibration. Vibrations were measured immediately next to the vehicle wheel, i.e. on the wheel holder), on the vehicle chassis, and on the vehicle steering wheel. The installed accelerometers for all the three measurement points are presented in Figure 5. Vibrations of the wheel and the chassis of the car were measured in the vertical "z" direction, while vibrations of the steering wheel were measured, beside in the "z" direction, also in the "x" direction, i.e. in the direction of driving of the car. Vibrations of the vehicle's wheel are important for considering the effects of unevenness of pavement on the vehicle's suspensions (shock-absorbers). Vibrations of the chassis are directly connected with comfort of driving and they show to what extent is the vehicle elastic. Vibrations of the steering wheel of the vehicle are important due to the fact that they are transferred directly to the driver's hands. That is particularly important in case of vehicles which are also the work posts of drivers (buses, trucks, delivery vehicles), and this phenomenon can be considered a direct exposure of a person to vibrations.

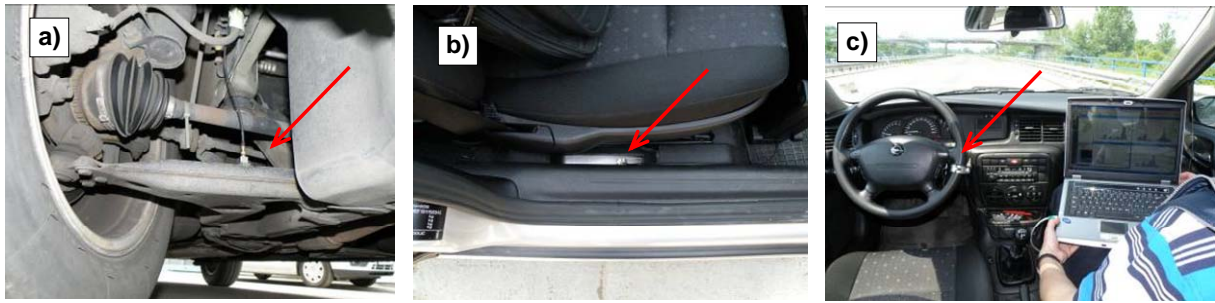
Figure 5: Positions of accelerometers: a) on the wheel holder, b) on the chassis, c) on the steering wheel

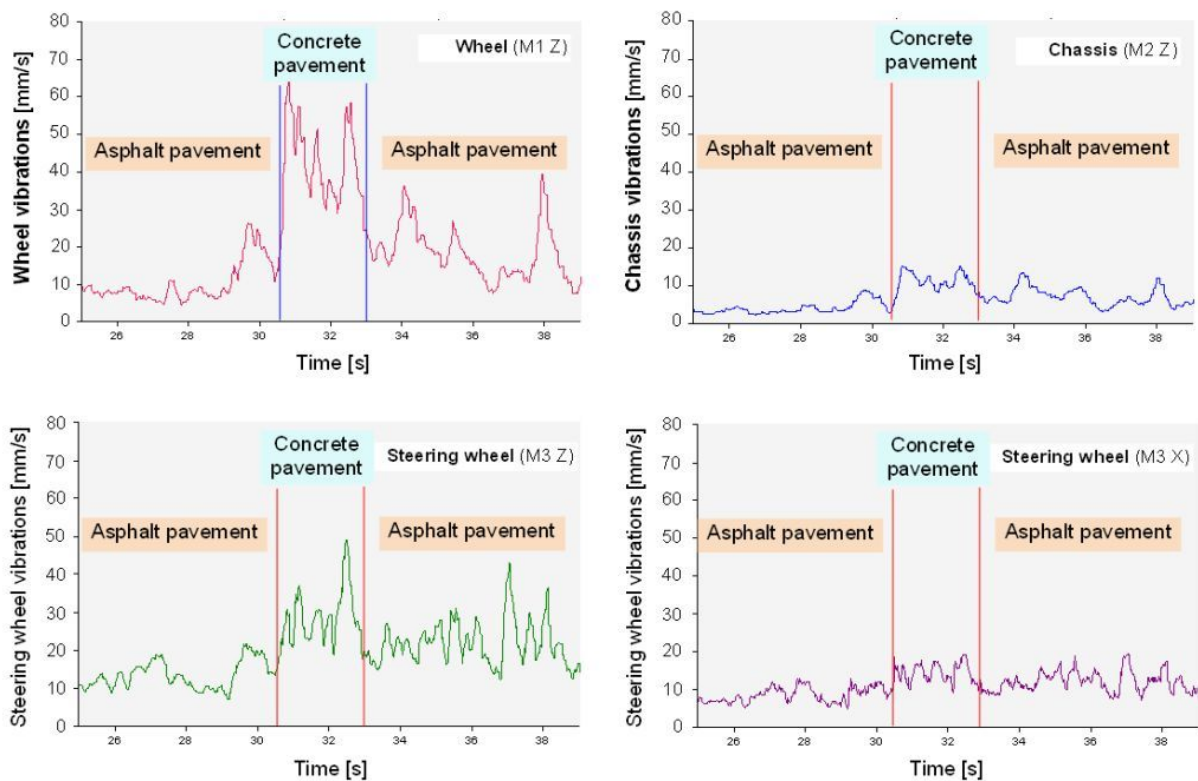
Figure 6: Vehicle vibrations at the speed of 130 km/h

As it was already mentioned in Item 2, vehicle vibrations were recorded at speeds from 80 km/h to 130 km/h. Figure 6 shows the results of measuring the vibrations of the wheel, of the chassis and of the steering wheel of the vehicle at the speed of 130 km/h.

In the time interval of 14 seconds, it is evident that greatest vibrations appear on the wheel of the vehicle and on the steering wheel of the vehicle in the vertical z direction. The maximum values of vibrations were obtained at the moment when the vehicle drives over the expansion joint of the bridge. The zone of movement of the vehicle along concrete pavement is specially marked in the diagram. The duration of movement of the vehicle along the test section at the speed of 130 km/h amounted to 1.7 s. However, in order to compare vibrations on concrete pavement with vibrations on asphalt pavement more precisely, average vibrations

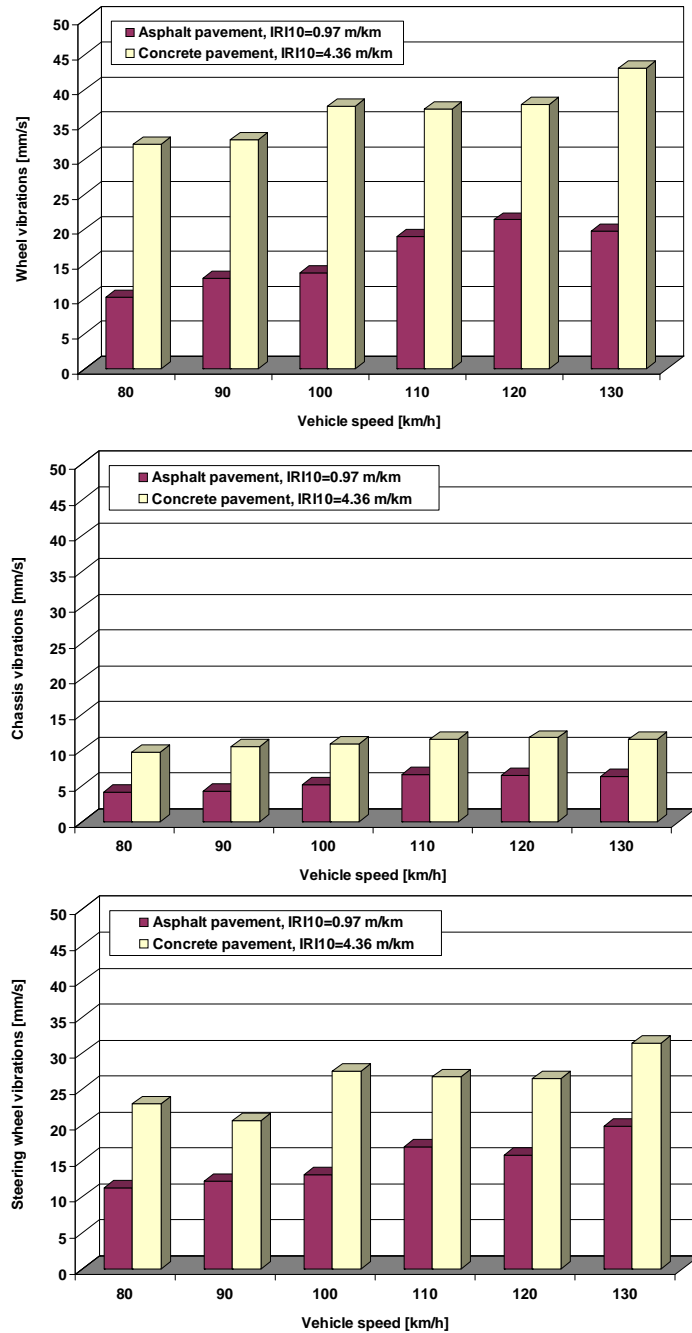
Figure 9: Wheel, chassis and steering wheel vibrations on asphalt and concrete pavement depending of vehicle speed

Vibrations on concrete pavement (on the bridge) and vibrations on asphalt pavements (before and after the bridge) are presented separately in Fig. 8. It can be seen that vibrations of the chassis are the smallest, and vibrations of the steering wheel on the z axis are only a little smaller than vibrations of the wheel. With the increase of speed from 80 to 130 km/h, vibrations of the wheel are two times larger after the bridge than before the bridge because of different irregularity of the driving surface. Detail view of wheel, chassis and steering wheel vibrations in vertical direction on asphalt and concrete pavement can be seen in Figure 9.
