Rehabilitation Design and Construction of PCC with AC Overlays Pavement of G328 Yizheng Section in China: a Case Study

Jiangsu Transportation Research Institute, Nanjing, Jiangsu, China

ABSTRACT: The design and construction of pavement rehabilitation projects is one of the greatest challenges afforded today's pavement engineers especially for those PCC with AC overlays. Case study of G328 Yizheng Section rehabilitation in China is provided in this paper. The G328 Yizheng Section was overlaid with 12cm asphalt concrete in 1998 on the original 24cm PCC slabs constructed in 1980. Due to serious pumping and faulting of the lower PCC slabs and drainage design defects, severe distresses like reflective transverse crack, longitudinal crack, water bleeding and pumping appeared in the AC overlays which influenced the driving safety and quality heavily. On the basis of comprehensive pavement evaluation and traffic analysis, the rehabilitation design with rubbilization of PCC slab combined with cold central plant recycling (CCPR) of old asphalt overlay using foamed asphalt with new AC overlays was recommended. Combination of the two "recycling" technologies-rubbilization and cold recycling-

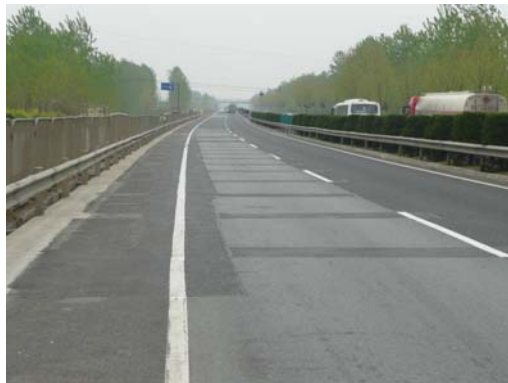
The main distresses includes severe reflective transverse cracks, water bleeding and pumping due to serious pumping and faulting of the lower PCC slabs, and the longitudinal crack appeared between the carriageway and hard-shoulder caused by the rigidity difference of the different structure of the carriageway and the hard-shoulder as given in Figure 1. Though many of the distress had been repaired or patched during routine maintenance, the pavement condition deteriorated rapidly and influenced the driving safety and quality heavily after 10 years service bearing growing traffic, and need rehabilitation and reconstruction.

(a) Transverse Crack (Patching)

FWD test was performed at 50m spacing on asphalt surface corresponding to the slab center and two adjacent slab corners of the both directions carriageway only. Figure 4 shows deflections of each slab center. It's easy to find that the deflections of slab center are between 5~50(0.01mm) and most are between 5~30(0.01mm) except few are over 30(0.01mm), which means the pavement still keep somehow good bearing capability. Also it can be founded that west bounded carriageway has better bearing capacity than east bounded carriageway, especially in the section K161+500 to K163+819 which corresponding to the sever distress and poor pavement condition as shown as an example in Figure 2 (a).

(1) The transverse cracks are most reflective cracks of underlying PCC slab joints due to serious pumping and faulting of the lower PCC slabs.

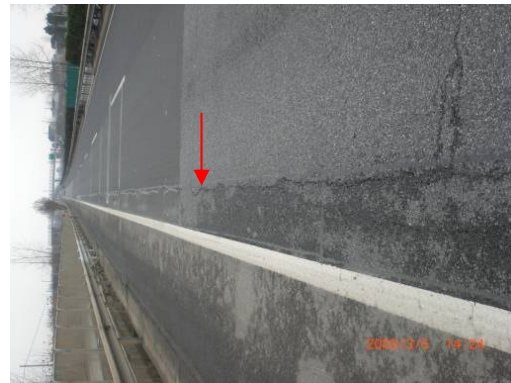
(b) Longitudinal Crack

(2) The longitudinal cracks appeared between the carriageway and hard-shoulder are caused by the different pavement structures of the carriageway and hard-shoulder as illustrated in Figure 1, which caused the rigidity difference, and clogged the horizontal drainage path of the carriageway asphalt layer at the same time.

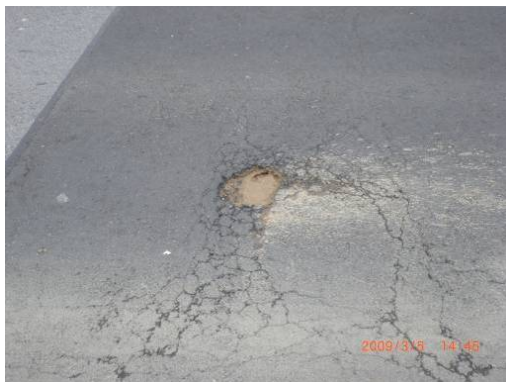
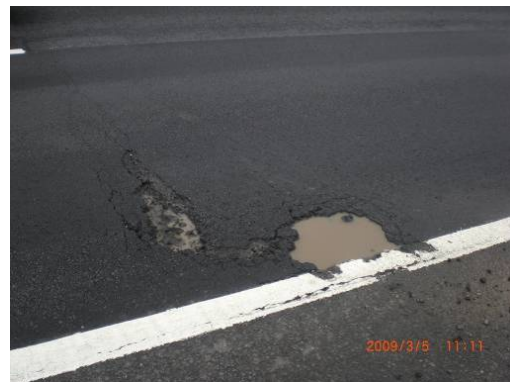
(c) Water bleeding and pumping

Figure2: Main distresses before rehabilitation

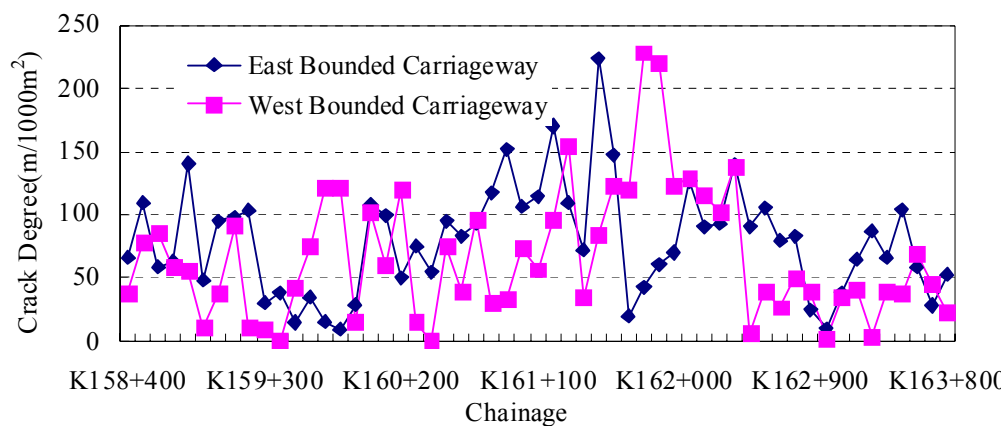
The pavement surface distress is also surveyed and evaluated by crack degree (CD) which is the crack length of every 1000m². It can be found in Figure 3 the highest crack degree up to 230m/1000m², which shows a very severe crack condition.

Figure 3: Crack degree of every 100 meters sections

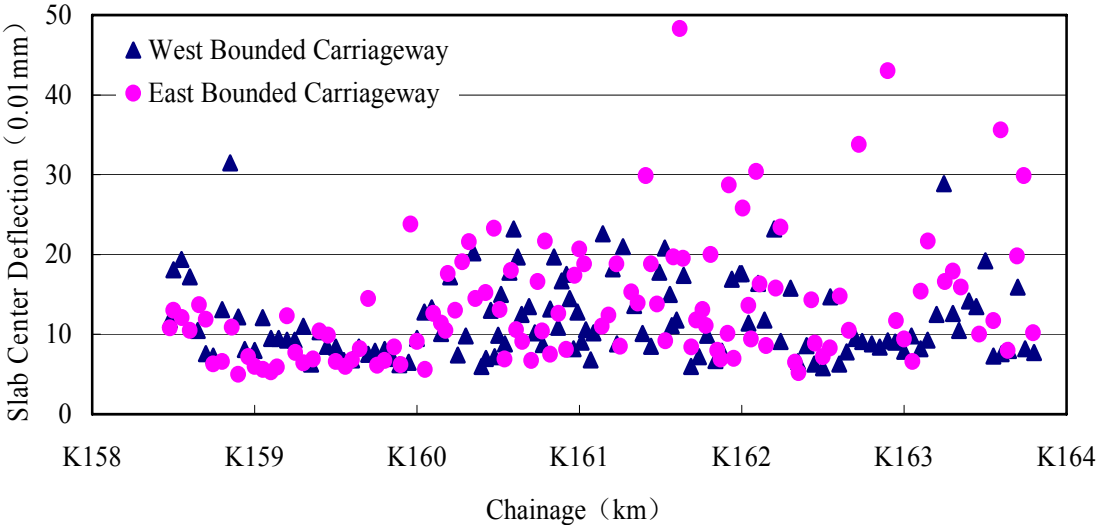
Figure 4: Deflection of each slab center
