Barrier Free Roads on Center Street in Takamatsu City

(Toward the Safe, Comfortable Traffic Road Sections for Pedestrians and Bicycles)

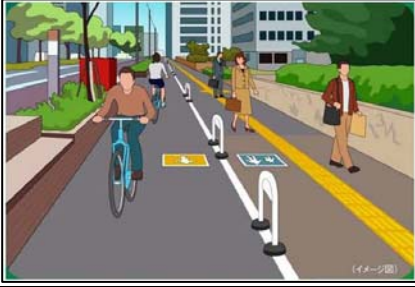
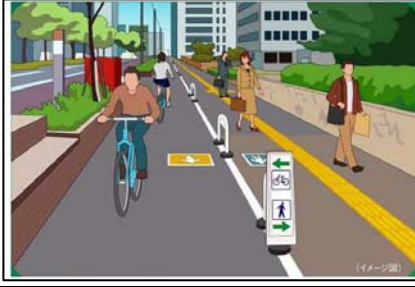
In such a background, the social experiments were conducted for the separation of bicycles and pedestrians in order to secure a safe, comfortable travel space for both of them. The image of the experiments and the verification items are as shown in Table 2.

Mode of verification	(1) Separation barriers only	(2) Separation Barriers and signboards
Image of the experiments

Verification items	<ul style="list-style-type: none"> ● How have the travel frequencies been changed between (1) and (2) above? 	
	<ul style="list-style-type: none"> ● Traveler's view 	
	<ul style="list-style-type: none"> ● Traveler's pros and cons 	
	<ul style="list-style-type: none"> ● How easily the travelers have recognized the separation of their space? 	
	<ul style="list-style-type: none"> ● How easily the signs can be recognized and understood in terms of their height and design? 	
	<ul style="list-style-type: none"> ● Safety by the separation barrier and markings 	
	<ul style="list-style-type: none"> ● Design, materials, color, etc. of the separation barrier and markings ● How effectively the traveler's behavior is changed by the barriers and markings?

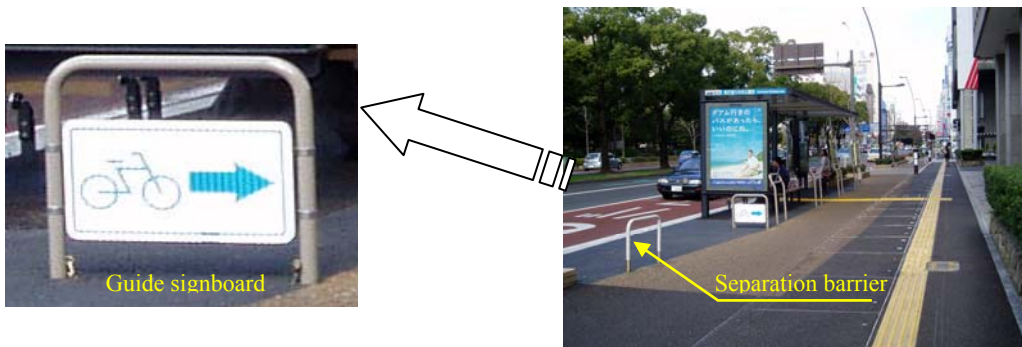
Photo 4: Separation Barrier and Guide Signboard around a Bus Stop

In addition to the separation barriers, a 1.2 m high guidepost was provided at each end of a sidewalk section and both sides of cross-roads. The existing 4.5 m wide sidewalk was divided to two parts of an equal width of 2.25 m as a basic module. Also, in the road section from Nakashin-machi to Kuribayashi Park, the previous above-ground planting boxes used for street trees and planting were removed, and trees were planted in an in-ground sunken type box to increase the width of a sidewalk, and railing type of traffic barriers were provided on the side of a vehicle roadway for the safety of pedestrians (see Photo 4, 5 and 6).

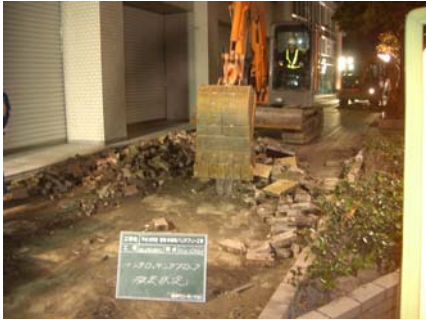
Photo 7: Removal Condition of the Previous Brick Blocks

The removal condition of the previous brick blocks is as shown in Photo 7, and the crushed and reclaimed brick aggregates at the treatment plant are as shown in Photo 8.

The present remodeling road sections were paved with brick blocks on the occasion of the underground utility laying work (CAB work) in 1987. Thereafter, as time passes, the joints of blocks have been stepped and bumpy, hampering the smooth travel by a bicycle or wheeled chair, and broken at vehicle entrances. It was considered very effective in the environmental policy and cost saving if brick blocks are crushed to pieces and used as colored aggregates for patterned pavements. For this purpose, studies were made to confirm such an idea in a practical aspect. Upon the finding of the practicability through experiments, Center Street in Takamatsu was dismantled of its brick blocks. They were collected in an asphalt plant where they were broken and screened out at its associated treatment plant as coarse aggregates (5 to 13 mm dia.) for use in permeable asphalt mixture.

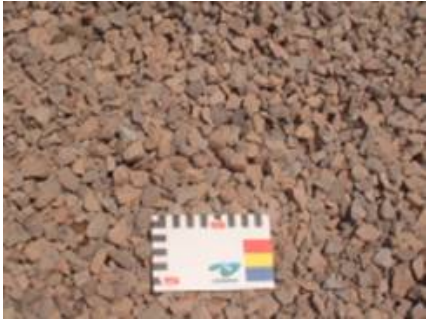
Photo 8: Reclaimed Brick Aggregates (5-13 mm)

The removed and collected brick blocks were crushed and screened out at the treatment plant as part of an asphalt plant for use as coarse aggregates (5 to 13 mm) for permeable asphalt

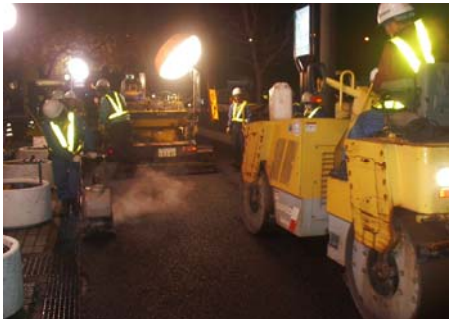
Photo 9: Laying of Surface Course (Rolling and Compacting)

In the same way as for the base course, the porous asphalt mixture with reclaimed-brick was rolled out by a mini asphalt finisher. Based on the result of Phase 1 work, the composition of

the color aggregates was changed to eight parts yellow chart and two parts reclaimed brick aggregates in order to improve the durability. The surface course installation is as shown in Photo 9.

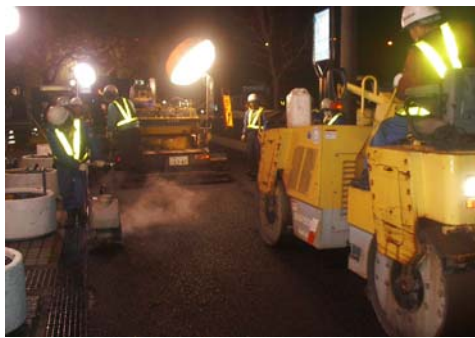
Photo 10: Water Jet Operation

On the bicycle zone, the pavement surface was treated by water jet operation to expose the aggregates and show a natural tone of aggregate color. The water jet operation is shown in Photo 10, and the exposure condition of the surface after the water jet treatment is shown in Photo 11.

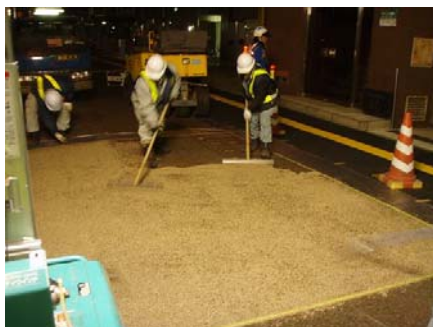
Photo 12: Surface Finishing Operation

The PRMS Method was employed to strengthen the surface portion for a vehicle access. In this method, red, yellow and white ceramic aggregates were mixed in a proportion of 1:1:1 respectively to obtain a bright tone for enhanced visibility. The surface finishing operation is shown in Photo 12, and the appearance of a finished surface is shown in Photo 13.

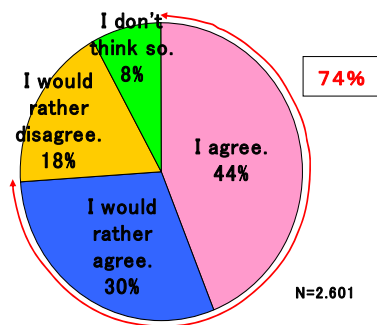
Figure 5: Answers to the questionnaire

A survey study was made by way of questionnaires and observation of travel conditions to know the results of the zone separation and the separation barriers and markings provided in the section of Center Street, Takamatsu City. The results are as shown in Figure 5 and 6.

On a safety aspect, 74% of the people who answered the questionnaire felt that the safety was improved. Also, the collateral effects were found regarding an improved manner of travellers, a feel of safety in the travel and an atmosphere of amenity. As for the observance of zone separation, traveling conditions of pedestrians and bicycles were observed two months after the installation of the separation barriers and markings. Both of pedestrians and bicycles were found to follow the separation rule at 90% in observation ratio and same ratio for the

In addition, 25% of the people answered that they became learned the zone separation rule applicable to the pedestrians and bicycles and that they became thought about the traveling manner about bicycles and pedestrians, thus noticeably deepening their awareness of sidewalk use. In this way, the remodeling has brought remarkable effects for the people.

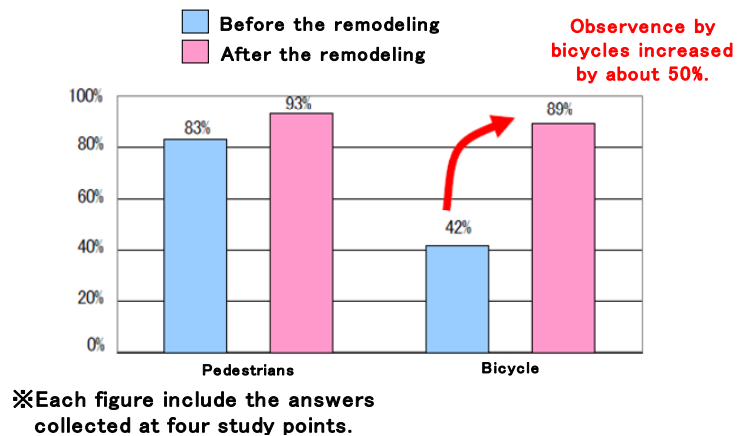
Figure 6 : Observance Ratios of Zone Separation (based on the travel study)

bicycles increased by 50% as compared with that found before the remodeling.
