Assessing the Integrity of Subsurface Drainage System Using Deflectograph Residual Life Data

ABSTRACT: Drainage is one of the key factors that jeopardises the integrity of the pavement. In most cases, impact from longitudinal sub-surface drains or adjacent filter drain failure results in the damage mostly to the nearside wheeltrack (NSWT), with less impact on the offside wheeltrack (OSWT). This paper aims to investigate if there is a relationship between the condition of the longitudinal drains and the residual life differences between the two wheeltracks of a given road, as obtained from Deflectograph surveys.

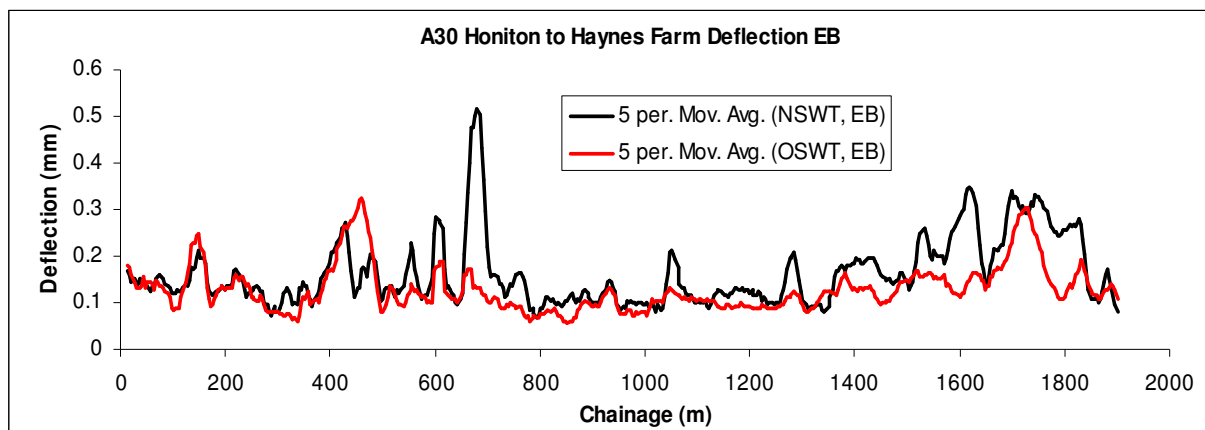
The Deflectograph profiles show that in a number of locations the NSWT deflections are higher than the OSWT deflections.

Chainage 600 to 800 and 1400 to 1800 EB: There is a marked increase in the NSWT deflections compared to OSWT ones. Drainage investigation shows that no drains are present in the same precise locations. This can mean that water is somehow flowing over the carriageway which has gradually reached the foundation, thus weakening the pavement along the haunches, possibly by soaking into the edge, where it is un-kerbed and possibly damaged.

On the other hand, the WB carriageway shows strong NS foundation, meaning that drains are not leaking.

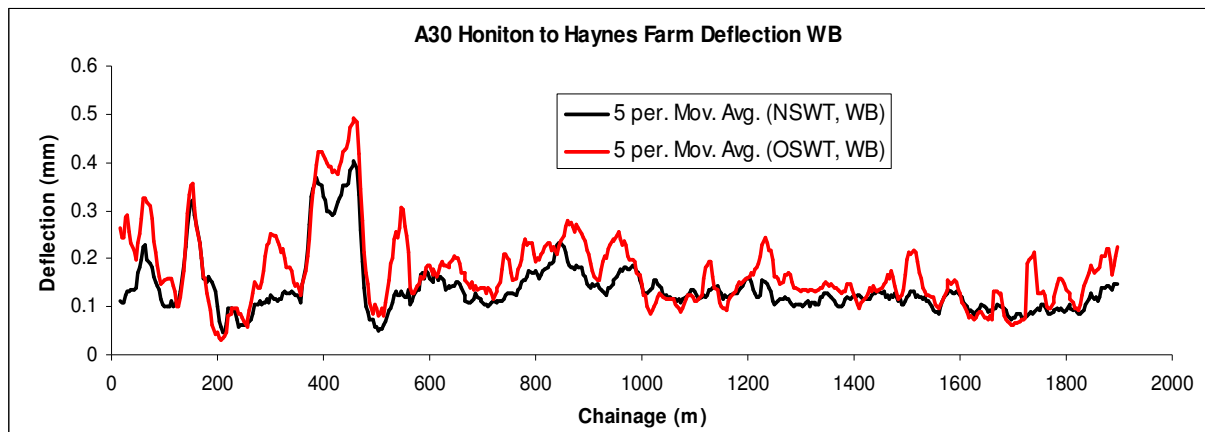
This can be due to a number of possible reasons:

1. The NSWT foundation is weaker in construction than the OSWT foundation. This sometimes happens on evolved roads (versus designed roads) whereby the road may have been historically a single track or a very narrow road which then widened naturally to a 2-way road (by current standards). It is worth noting that current standard for a lane width is 3.65m as opposed to the 3.1m noticed in some parts of this piece of road.

2. The testing is not consistent on very narrow roads where the Deflectograph testing relies on the nearside wheels sitting near the edge (i.e. considering a 2.75m for the width of the machine, the measurements on the NSWT are located some 150mm away from the asphalt edge). This can skew the results thus making this hypothesis not consistent along a piece of road that does not have uniform lane width.

3. The NSWT foundation has been weakened as a result of the effect of seepage water from failed drains that are located near the road edge. This is the main element of the proposed hypothesis that is being checked in this analysis.

4. The assumed weakening of the foundation beneath the NSWT is perhaps due to localised strengthening of the OSWT foundation (i.e. due to deep localised patching or a stronger trench reinstatement), thus making the deflections on the OSWT lower than those along the NSWT. This can be ruled out by studying the general deflection trend along the route. Also, with seed moduli for the bound layers, it is possible to use layer-linear elastic modelling (i.e. BISAR) to predict the strength of the foundation - this can be used to verify the Deflectograph indications. For the purpose of illustration in this paper, the 5 moving average values of the deflection profiles have been shown to illustrate the general trend of defects at every 20m intervals. Although it is possible to analyse individual deflection values (taken every 4m), reporting will be beyond the scope of this paper.

5. There appears to be a direct relationship between the lack of drainage and weakening of the NSWT foundation when the surface water flows towards the nearside verge. This is expected as water would gradually seep through the verge into foundation. Any signs of wheeltrack cracking on the surface would be an indication of water seepage as well.

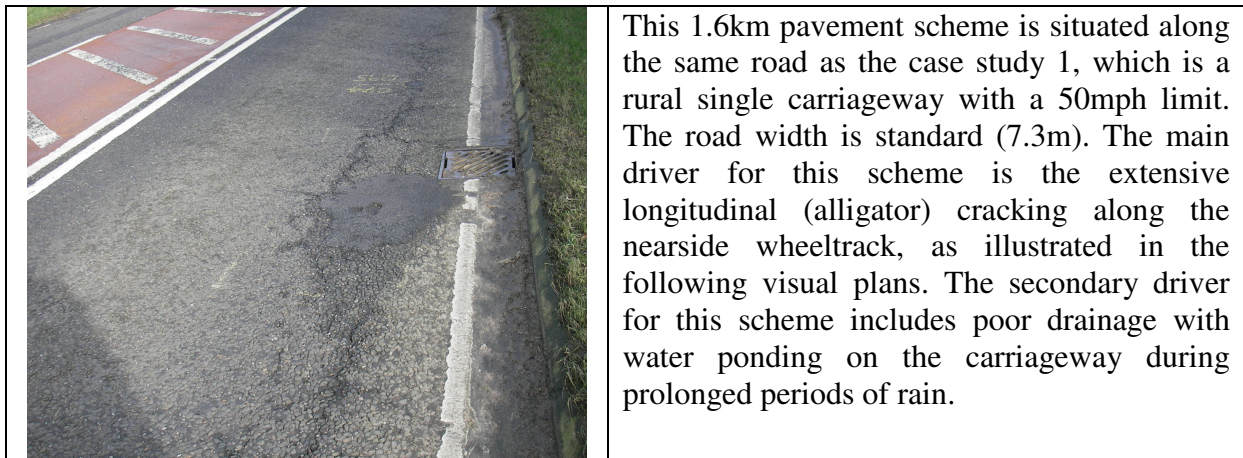
Of the full length of the scheme, only 550m has subsurface drainage (chainage 950 to 1500m along both the EB and WB carriageways). Of this length of drain pipes, 400m have failed and need replacement (as identified by CCTV survey).

The site is located along a cutting to the south (adjacent to the WB carriageway edge) and a deep embankment to the north (on the EB carriageway edge). Hence, any surface water running down the cutting is not able to be absorbed by the verge, hence crossing the WB carriageway and flowing down the embankment of the EB carriageway. The flooding has resulted in extensive surface cracking and ravelling / disintegration.

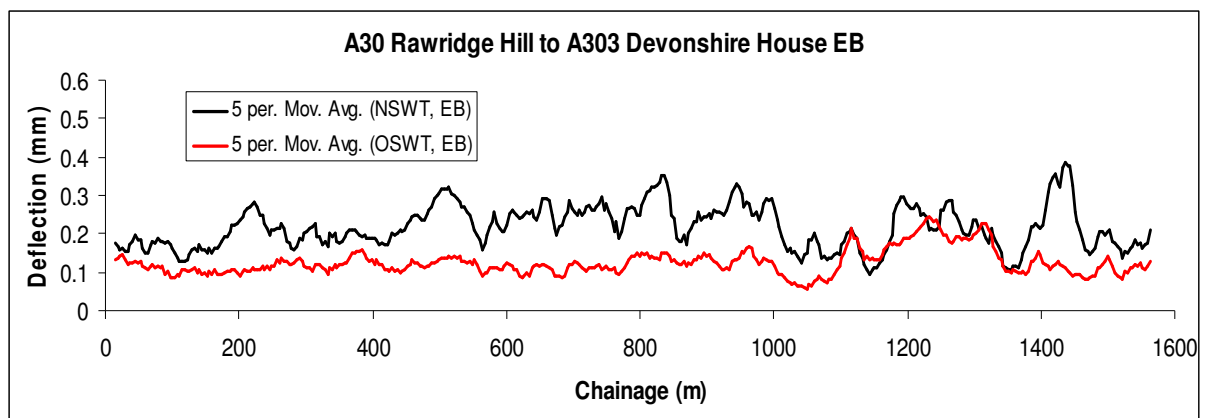
The deflection profile on the NSW T shows a similar response in the pavement foundation between areas where there is no drainage system but there is surface cracking and areas where there is drainage but the drain pipes have collapsed/broken. Both cases allow water to enter the foundation, resulting in higher deflections on the NSW T in comparison to OSWT. This appears to be the case in both EB and WB directions.

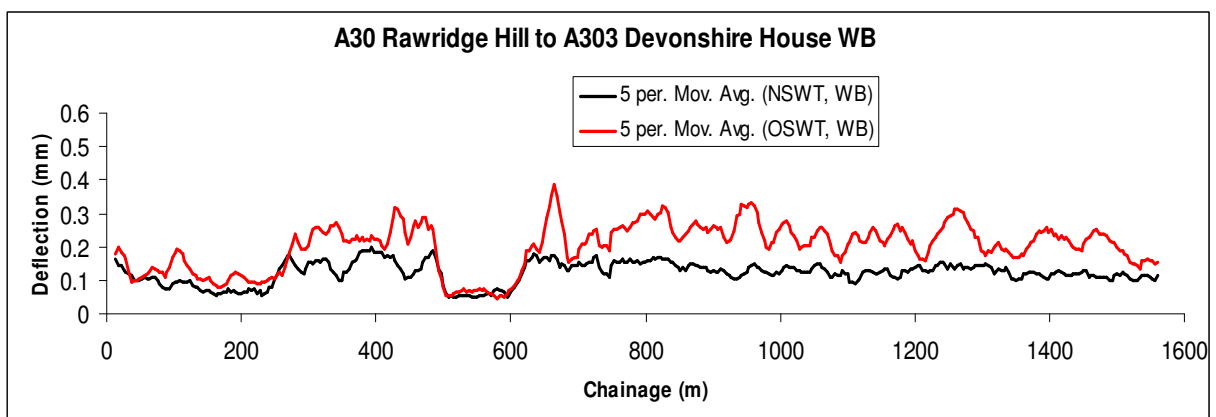
It is worth noting that where the wheeltrack cracking has occurred in both the NSW T and OSWT of the EB (i.e. chainage 1100 to 1350m of the EB carriageway), the deflection profiles converge to a value similar to that in the rest of the NSW T where there foundation has softened.

In comparison, the WB carriageway shows higher deflection on the OSWT in comparison to the NSWT. This can be seen by the joint cracking on the centreline of the road (see the visual survey illustration given previously for chainage 1000 to 1200m). This trend is similar to that found in the first case study where water entering through the centreline cracks has weakened the foundation of the OSWT in the WB carriageway.

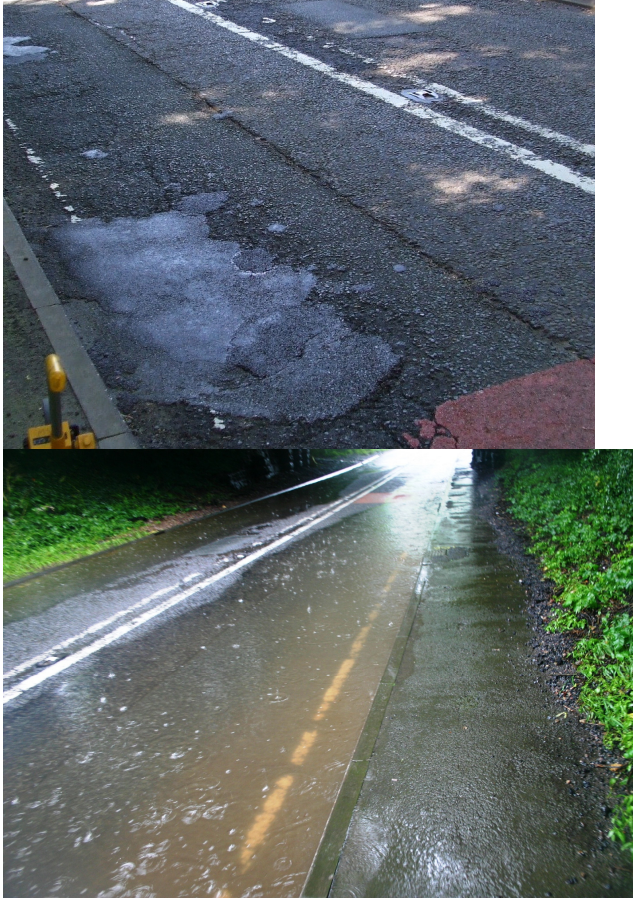
(On-carriageway walked visual survey)

<p>The A40 from Huntley to Lea is an evolved single carriageway trunk road of varying construction. The main driver for this 6km pavement treatment scheme is the extensive surface disintegration and localised wheeltrack cracking.</p> <p>Visual survey has shown that during heavy rain, water tends to flow on the NSWT for a great deal of the scheme length. However, wheeltrack cracking defects are only localised to certain locations.</p> <p>The CCTV surveys showed substantial number of drainage defects or lack of provision of drainage along the scheme length. In specific places, this is causing accelerated failure of the pavement surface. Flooding and collapsed gullies have been the cause of emergency call outs in the last twelve months.</p>
--	---

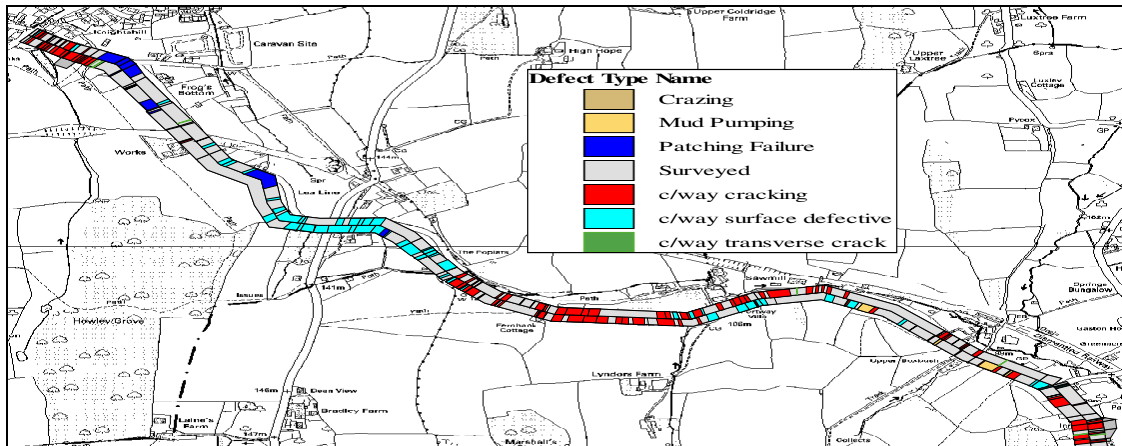
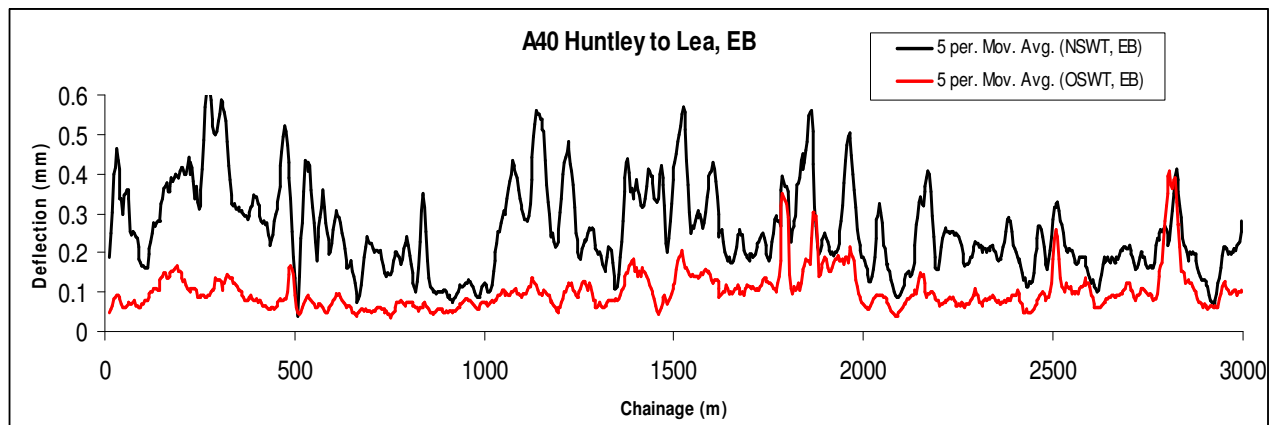
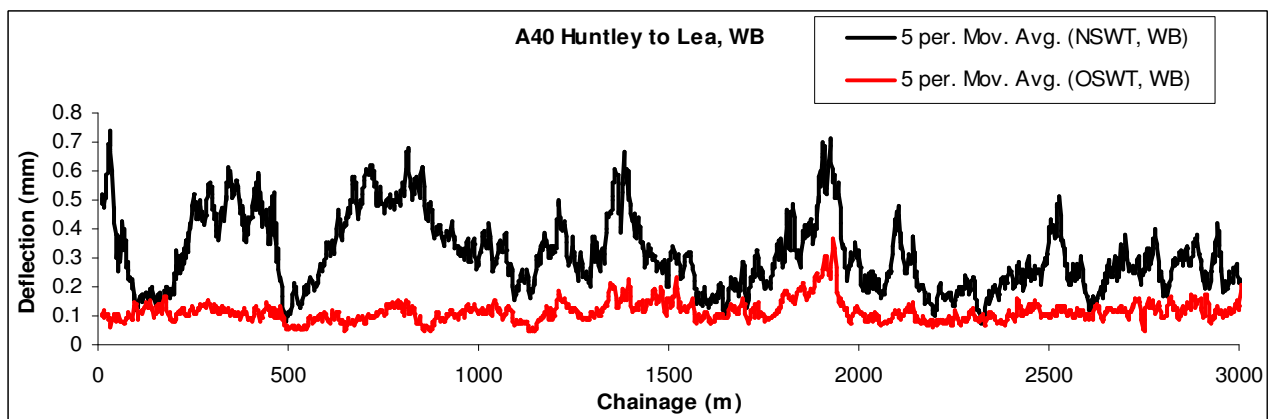
Profiles of the deflection values indicate a very weak foundation for the NSW for the majority of the scheme length in both directions. This can be expected given the amount of ponding on the pavement, wheeltrack cracking and softened verges as a result of water runoff. There was a known drainage scheme at Boxbush (located between chainage 1712 and 1900m) which caused major flooding of the carriageway. The carrier drain had reduced capacity due to excessive silting, causing the water to flow over the carriageway. Hence, the NSW deflection is at its peak value at chainage 1900m on the WB direction. The same trend is also evident on the EB direction.

This case study clearly indicates a distinct correlation between failures in the carrier drain or the

presence of wheeltrack or other carriageway cracking and the deflection response from the Deflectograph surveys.
