A Sophisticated Overlaying Approach to Improving Riding Quality for Aged Concrete Pavement in NEXCO

ABSTRACT: A 35km long section with cement concrete pavement in Chuo Expressway has been in operation over 35 years as a heavily trafficked beltway for carrying 20,000 truck vehicles a day. Recently cracking and joints faulting have come to arise remarkably in the concrete section and there have been claims about decrease of riding quality form toll users. In order to improve both riding quality and durability, a big overlaying project that continues several years had to be planned. Since the beltway cannot be closed, the given repair condition was really tough; asphalt materials need to be overlaid for every 3 kilometer long lane section during 4 days, while the other lane being open to traffic. In addition to assuring road safety during repair works, a durable repair method that also assures riding quality has to be selected. As a durable asphalt mix reported in Zurich ISAP symposium 2008, 4cm hybrid mix was selected. It is composed of rough macro texture similar to that of porous asphalt, as well as the same waterproof as that of stone mastic asphalt. Since the occurrence of refle

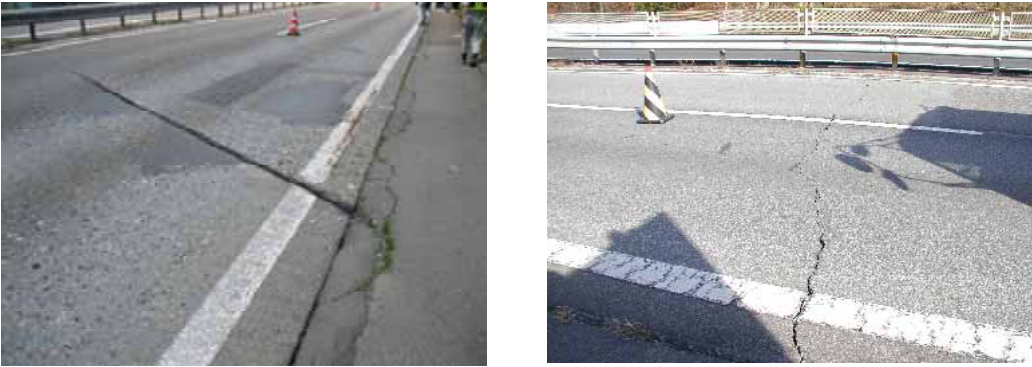
Figure2: Joint faulting (left) and transverse crack (right)

Hachioji Bureau of Central Nippon Expressway Company Limited manages about 305km length of Chuo Expressway between Tokyo and Nagano. Of the entire sections, concrete pavement is shared with approximately 36km (Figure 1). Over 30 years has passed since this section opened. Recently the damages of crack and faulting of joints occurred on the pavement slabs (Figure 2). As a result, riding quality has been worsened by outbreak of traffic vibration with remarkable noise, and thus this entire concrete section has come to be repaired immediately.

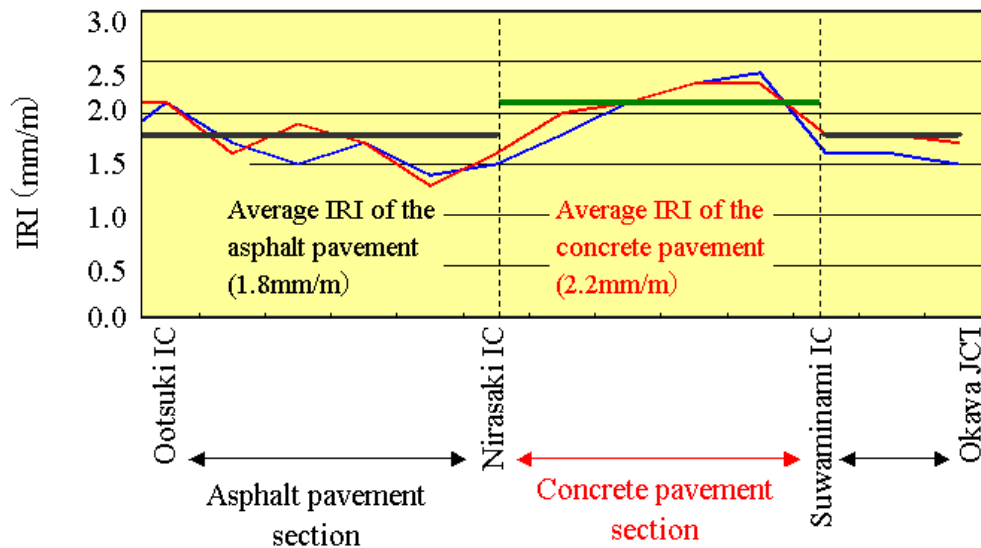
Figure 3: Comparison of IRI

The concrete pavement section has been damaged with reduction of riding quality because of aged deterioration, although it seems still structurally sound. Table 1 shows a road surface property, and Figure 3 shows IRI (International Roughness Index) of the existing concrete pavement. The concrete pavement is generally in a good state, but over 20mm rutting is seen partially. IRI is 2.2 mm/m on average of the concrete pavement section, while 1.8 mm/m on that of the neighboring asphalt pavement section. In addition, the point with more than 4.0mm/m was confirmed partially in the former, too. According to a riding quality study performed in the past, IRI 2.2 mm/m is the level in which more than 50% of passengers begin to feel not good in riding on the roadway (Kamiya, 2005).

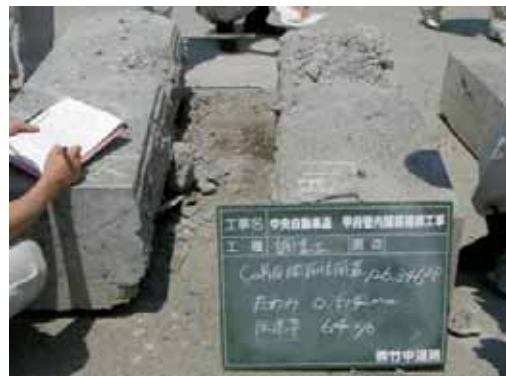
Figure 6: Point with slip bars broken (load transmission 64%)

As shown in Figure 6, four out of five slip bars were found broken at the points with the transmission ratio being 42% and 64%. On the other hand, only one slip bar was broken with the ratio being 82% and 77%.

Finally it was judged that the ratio of load transmission be 70% or lower as criterion for bar-stitching. Moreover there could be a cavity under the concrete slab when the FWD maximum deflection is 0.4mm or higher. Therefore it was also determined that under-sealing should be done in case of this deflection level.

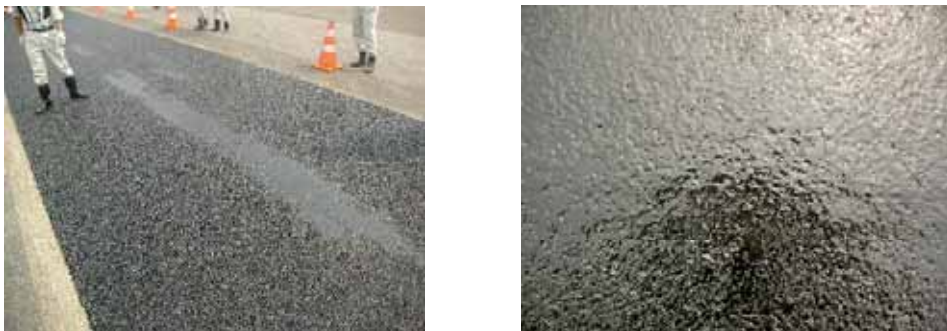
Figure 9: Asphalt run-off problems (Ordinary modified asphalt, SBS 4%)

Although polymer modified asphalt is usually used for hybrid mix, the occurrence of bleeding or asphalt run-off problems were much concerned during construction. This is because it took as long as 70 minutes for shipping materials from asphalt plant to the paving field. For the purpose of avoiding those asphalt problems, the type of modified asphalt was needed to examine. In simulation of the shipping time, Figure 9 and Figure 10 show photos in case of using ordinary modified asphalt and highly polymer modified asphalt, respectively. The SBS content of the former is 4% and that of the latter is 8%.

The test pavement with SBS 4% had run-off and flush of asphalt, while SBS 8% didn't. Therefore highly polymer modified asphalt was adopted in 2006 and in 2007.

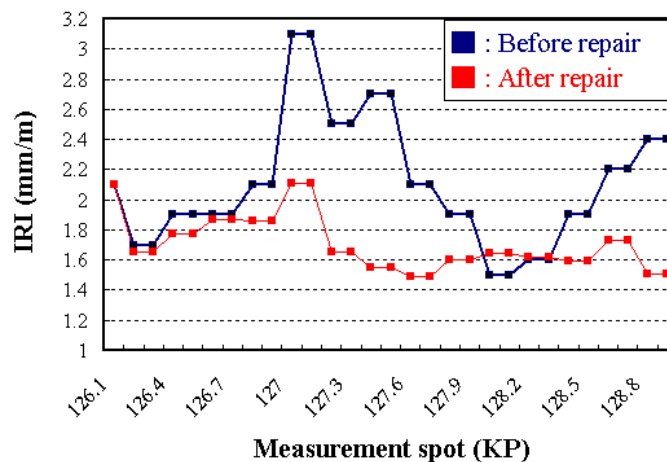
Figure12: Improvement of IRI

Figure 12 shows the improvement of IRI on average from 2.1mm/m to 1.7mm/m. However because there still remained wobble vibration at the concrete joints, there was still room for improvement at the joints.
