Thermal Imaging Technology: Quality Control and Quality Assurance for Construction of Warm and Hot Mix Asphalt Pavements

M. M. Elshafey, C. Herry, A.O. Abd El Halim & R. Goubran

Department of Civil and Environmental Engineering, Carleton University, Ottawa, Canada

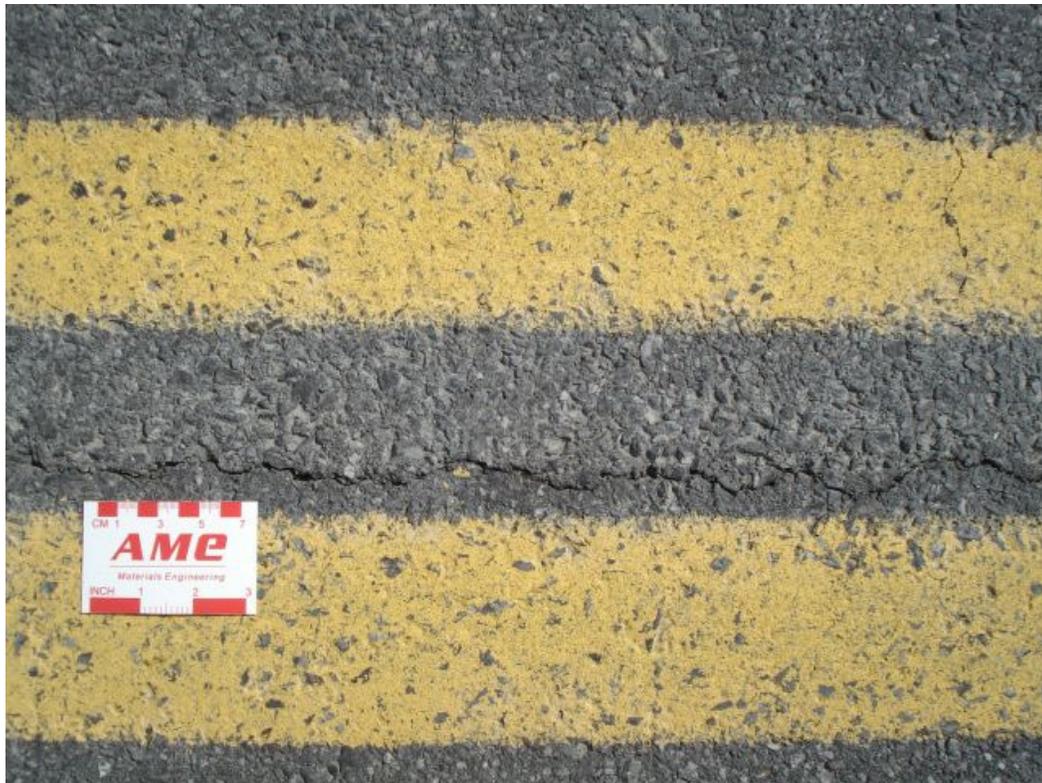
In fact, the only distress observed was related to the longitudinal joints. For the Sasobit® WMA section, the joint has opened with slight severity (3 to 6 mm crack width) for 280 m of the total section length of 1262 m, or 22.2 percent of the section length. For the HMA section, the longitudinal joint had opened with slight severity for 760 m over the total section length of 1838 m, or 41.3 percent of the section length.

a) Typical Joint Opening in Hot Mix Asphalt Section of Victoria Road

Figure 6: Longitudinal Joint in Hot and Warm Mix Asphalt Sections After 2 Winters

Figure 6 displays a comparison of the typical joints for the hot (6a) and warm mix (6b) sections. Continuing evaluation is required, but initial performance suggests that WMA provides better longitudinal joint performance than HMA (all else equal). The performance of Victoria Road will be monitored with time to confirm these initial results. It is interesting to note that the other two WMA trials (Evotherm® and Hypertherm™) currently display no opening of the longitudinal joints for either their respective WMA or HMA sections.

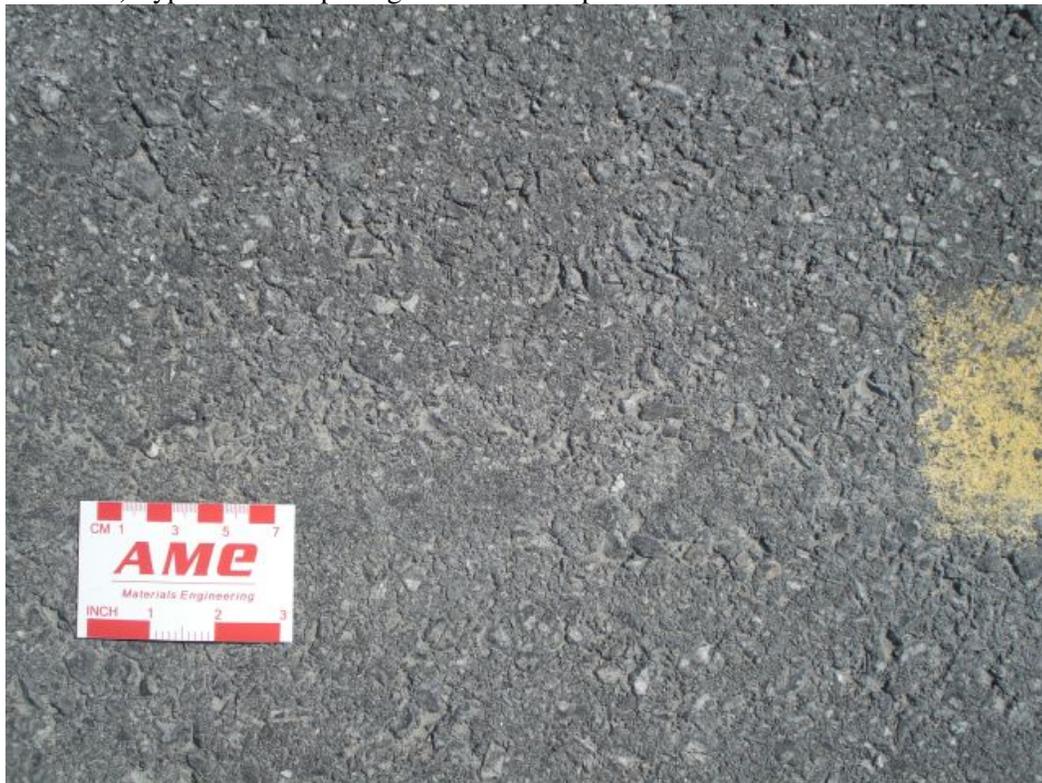
b) Typical Joint in Warm Mix Asphalt Section of Victoria Road
