# Stripping Phenomenon in Thick Pavement Top Layers

**ABSTRACT:** Most of the heavily trafficked French roads, like thick pavement structures, are now thirty or forty years old. Since construction, top layers only, have undergone one or more repair operations. Traditional rehabilitation works consist in overlaying the old wearing course or in milling it before covering it with a new overlay. For a few years, unusual deteriorations in highway structures, like pothole series or top layer delamination, have appeared. These phenomena generally occur after winter and more precisely during rainy events. The purpose of this paper is to investigate three cases of degradations observed for both rehabilitation types. The mechanics of the action causing upper layer deteriorations has to do with freeze-thaw processes combined with humidity and traffic. Nevertheless, other causes can add further to pavement degradation long before any surface deteriorations appear. The presence of water near the surface, for instance, can explain some of the damages observed. The fatigue of the layers during hot weather periods can also be at the origin of damages, even though rutting is more traditionally exp

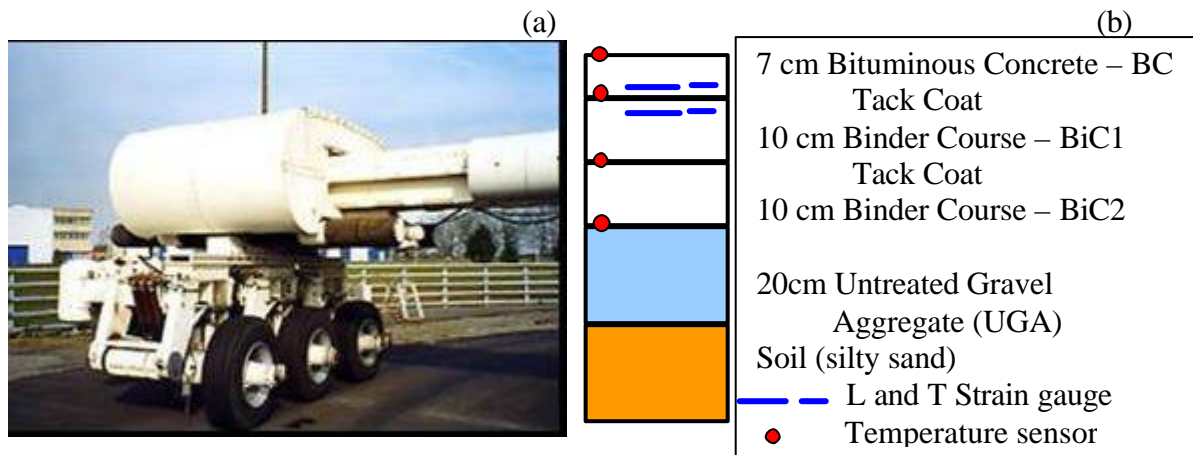
This section presents a study conducted using the LCPC’s circular test track facility to examine an instrumented pavement very similar to case 3 pavement structure (Figure 5a). An interesting finding of this experiment is the partly unexpected behaviour of the first interface, which varies significantly depending on the temperature.

The objective of the test is to examine stress on both side of the wearing course/binder course interface on a thick pavement structure (Figure 5b). The moving load consists of a large wheel triple axle equipped with type 385/65 R 22.5 Dunlop tyres. The gauge of wheel is 138 cm. Transverse and longitudinal gauges are embedded in the lower part of the BC layer and in the upper part of the binder course (Binder Course 1- BiC1). Temperature sensors are placed at all the interface levels within the structure. Structure implementation conditions are satisfactory. The tack coat quality between each layer is good with a residual bitumen content of 300g/m<sup>2</sup> within the emulsion. The pavement reference deflection value is 30 1/100 mm under a 130 kN dual wheel axle at 15°C for a load velocity of 3.5 km/h. For recording the signals, the triple axle is positioned so that the load is applied with the middle of the tread of tyres passing right above the sensors placed inside the pavement. The load applied by each wheel is 42.5 kN at a speed of 42 km/h. Measurements are carried out for both temperature profile presented in Table 2.

Figure 5: Configuration of the LCPC's circular test track experiment  
 (a) Large wheel triple axle running gear (b) Pavement structure and instrumentation.

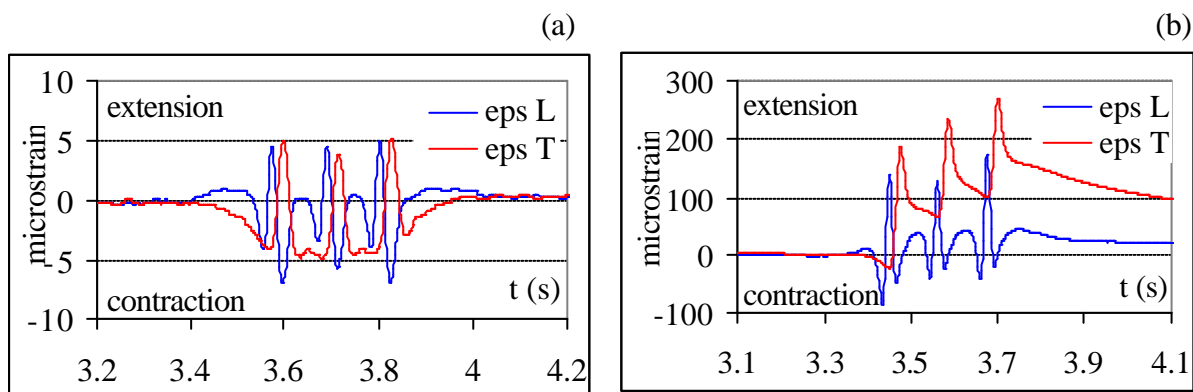
The charts of the recording instruments plot the deformations measured at the bottom of the wearing course (Figure 6) and at the top of BiC1 (Figure 7) for both profiles. The curves display some significant microstrains with opposite signs on both sides of the interface at high temperatures. They reveal some displacements of the layers despite the tack coat good adhesive capacity as proved by the core samples extracted from the pavement at the end of the test. On the other hand, in cold or temperate conditions, the deformations are much smaller and correspond to contraction or very small traction effects at the bottom of the wearing course, and to contractions in the upper part of the binder course.

Figure 6: Microstrain signal at the bottom of the BC course.  
 (a) Microstrains for profile 1. (b) Microstrains for profile 2.

Figure 6b presents transverse deformation values 1.6 times higher than longitudinal ones, which could account for longitudinal cracking. However, it is also possible, in these conditions, that a fatigue event with delamination specific of the interface is being observed. Elastic structural computations using the Alizé software (Autret et al. 1982) ([www.lcpc.fr](http://www.lcpc.fr)) or viscoelastic ones using ViscoRoute software (Chabot et al. 2010, Chupin et al. 2009) performed with data sets corresponding to the temperature and interface conditions described, confirm the argumentation. They also can be used to clarify the demonstration through a comprehensive study of strain and stress fields.

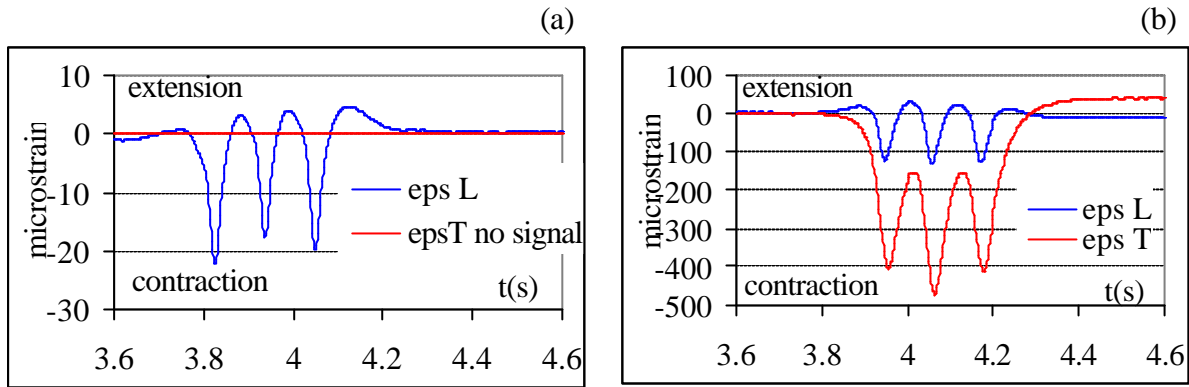
Figure 7: Microstrain signal at the top of the first binder course.  
 (a) Microstrains for profile 1 (b) Microstrains for profile 2.

As expected, multi-layer elastic simulations show that such measurements correspond to what could be called “quasi-stuck” behaviour. The measurements then prove that the “mechanical efficiency” of the tack coat is highly dependent on the temperature. Consequently, as confirm by the simulations carried out with a “sliding” interface, this could account for in-traction fatigue crack initiation at the bottom of the wearing course and at the level of the wheel tracks, when the temperature is high. Eventually, resulting macroscopic surface cracking can then appear.
