# The Credibility of Visual Survey Result against Pavement Performance Analysis

**ABSTRACT:** In order to maintain the pavement in good condition in its service periods, periodical diagnosis, proper treatment and repair based on the diagnosis, and appropriate follow-up shall be important. The evaluation by visual survey by a pavement engineer and a longitudinal profile and rut survey vehicle will be two universal methods for the diagnosis.

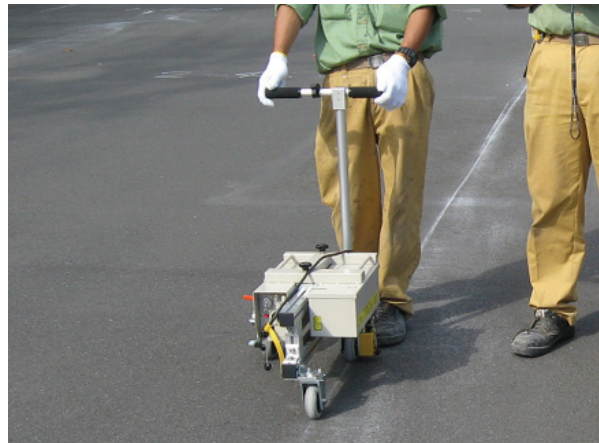
Figure 2: Multi-Road Profiler

MRP is one of inertial profiler. We use MRP to measure longitudinal profile, micro-texture and rut depth. IRI is computed according to the quarter-car model using the profile data of MRP. The appearance of MRP is shown in Figure 2.

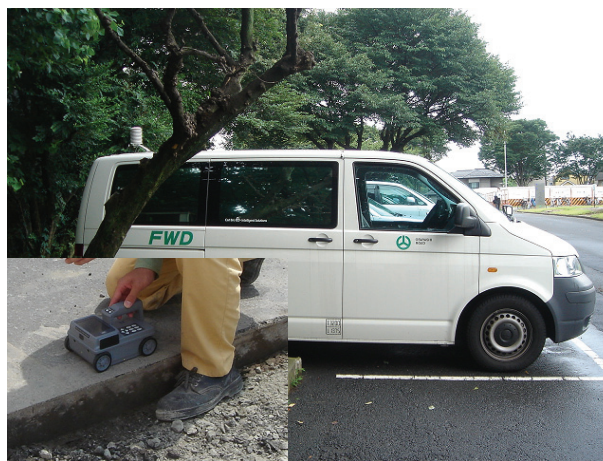
Figure 3: Falling weight deflectometer and electromagnetic waves

In order to comprehend the degree of the structural damage of pavement, we measured the deflection using FWD. It was measured in the arbitrary positions of the block where an obstacle does not exist. Moreover, because the structure of pavement is unknown, thickness of the pavement was estimated using electromagnetic waves.

Thus, the temperature-correction value of the deflection was calculated by the air temperature, surface temperature, mean temperature of pavement and pavement thickness.

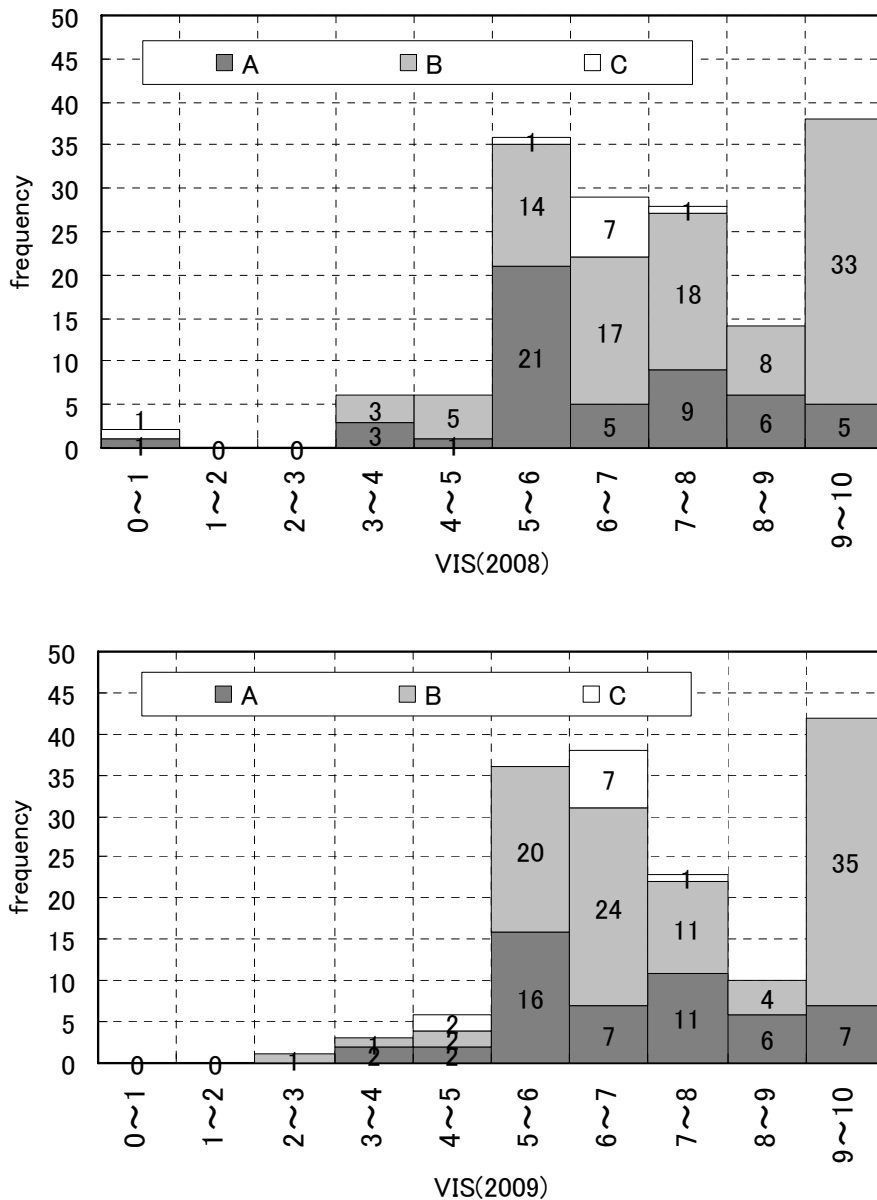
Figure 4: The distributions of VIS

Figure 4 shows distribution of VIS obtained by visual survey. The number beside VIS expresses the year which investigated. As may be seen from Figure 4, In “B” zone, there are many blocks of the class in which the VIS is higher than “A” zone.

Moreover, the dispersion of the score in “C” zone is small. Since heavy vehicles run frequently in “B” Zone, rehabilitation is periodically carried out so that the pavement can maintain a desirable state.

We hope it is possible to estimate the rate of deterioration from two graphs. We did not find remarkable difference between them in “A”, “C” zone. However, in “B” zone, we can find differs clearly. These graphs show that the pavement deterioration rate in “B” zone is higher than other zones. A few damaged blocks are repaired in every year, and any blocks which were evaluated low does not exist in the next year.
